FORD E40D "UPDATE HANDBOOK"

INTRODUCTION FORD E4OD "UPDATE HANDBOOK"

**FORD E40D
VALVE BODY, SPACER PLATE, SPACER PLATE GASKETS,
CHECKBALL LOCATIONS, AND CASE CHANGES,
FOR THE 1996 MODEL YEAR**

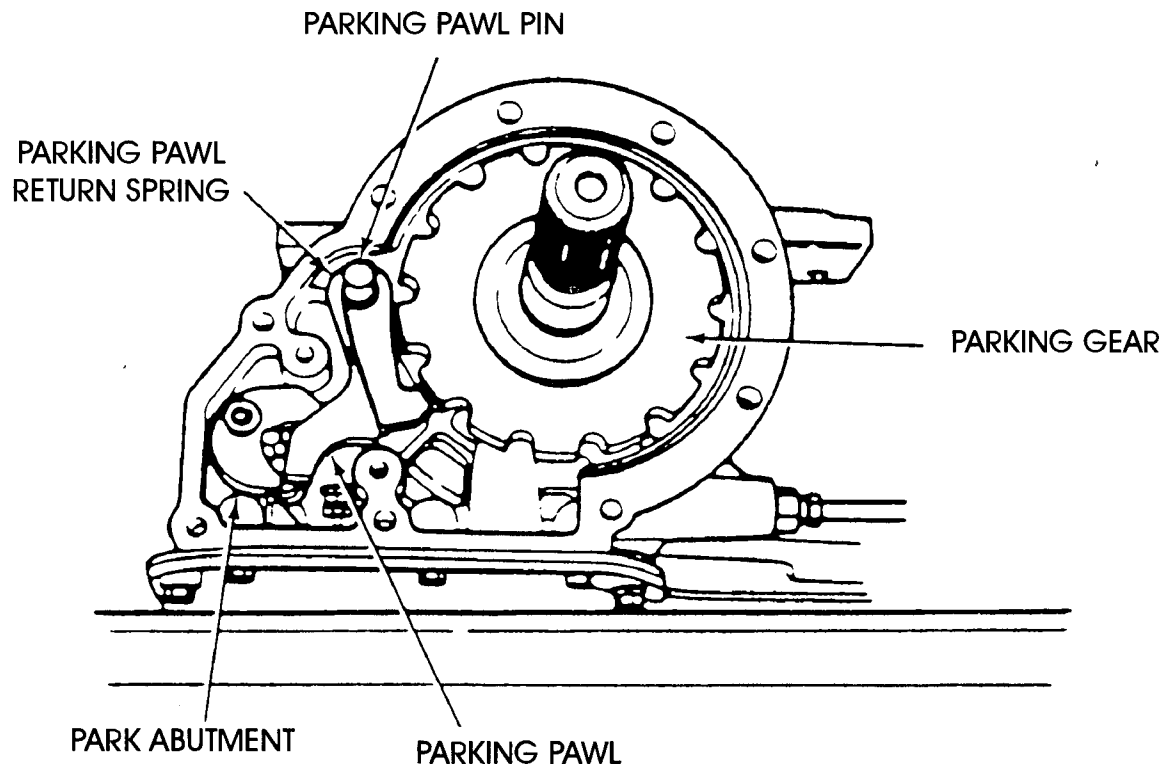
Figure 22

CAUSE: The cause may be a broken snap ring on the output shaft, allowing the parking gear to move rearward, and then the parking pawl cannot engage into the parking gear. Refer to Figure 22.

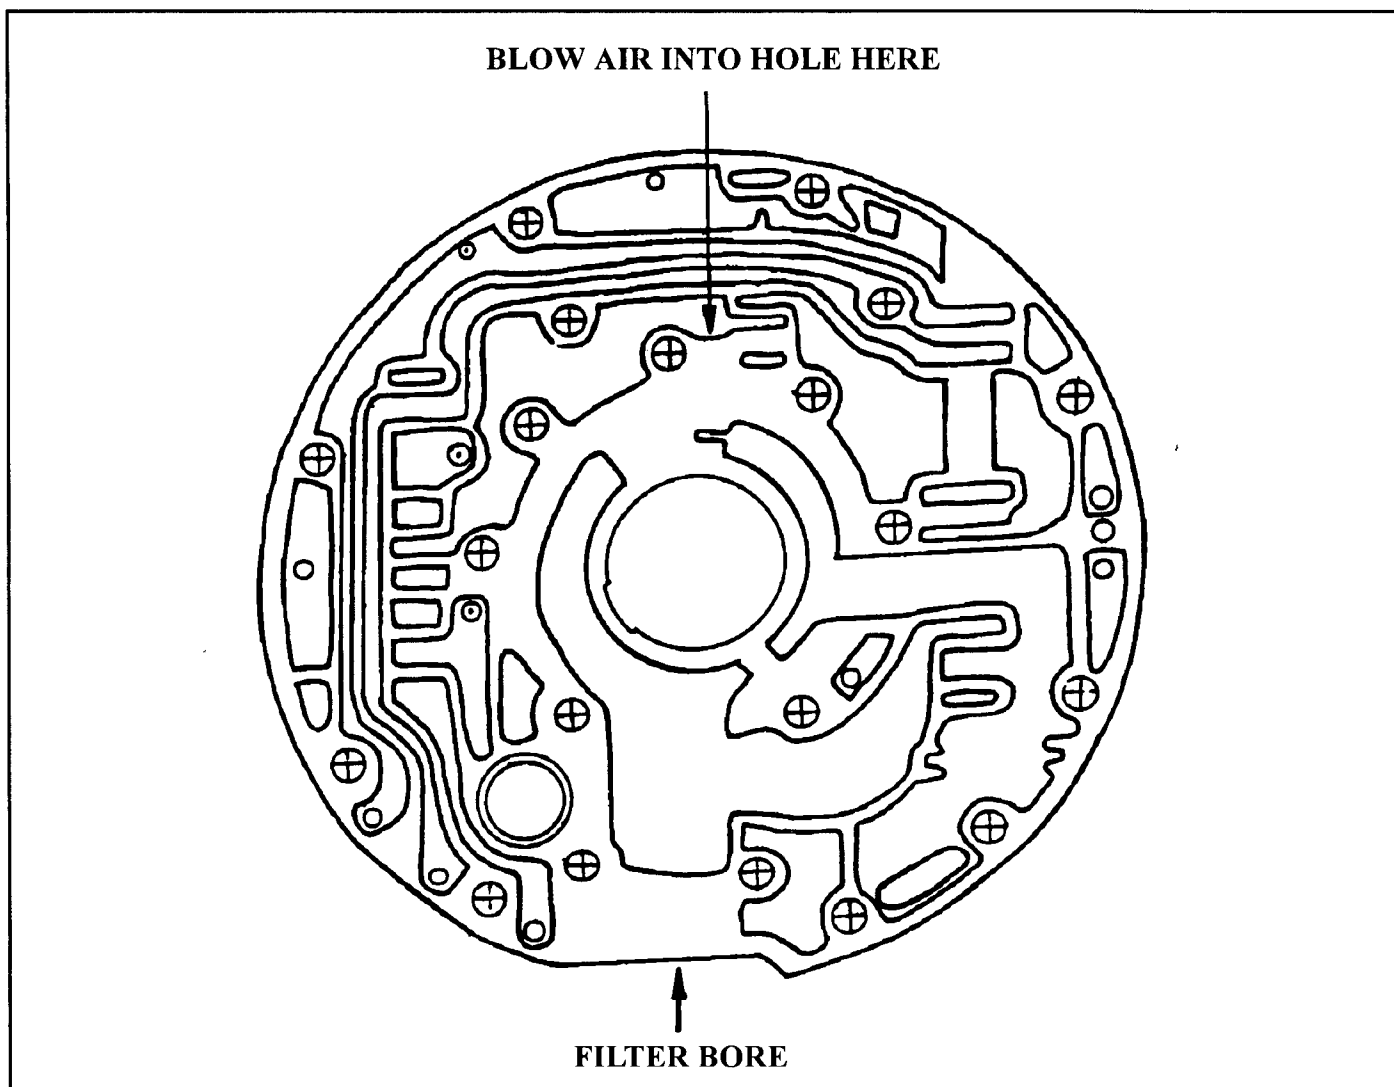
Figure 27

COMPLAINT: Overdrive planetary and overdrive sprag failure due to lack of lubrication.

CAUSE: The cause may be, a plugged or restricted lube passage in the oil pump cover. There is a valve and spring under the orificed cup plug in the pump cover. The valve is made of plastic and is prone to melting, and will restrict or block the passage.

CORRECTION: To check for restriction, blow air into the hole in pump cover as shown in Figure 27, and air should exit from the holes in rear of stator shaft, as shown in Figure 28. If the passage is restricted or blocked the orificed cup plug must be removed, the plastic valve assembly replaced, and the passage thoroughly cleaned (See Figure 28)

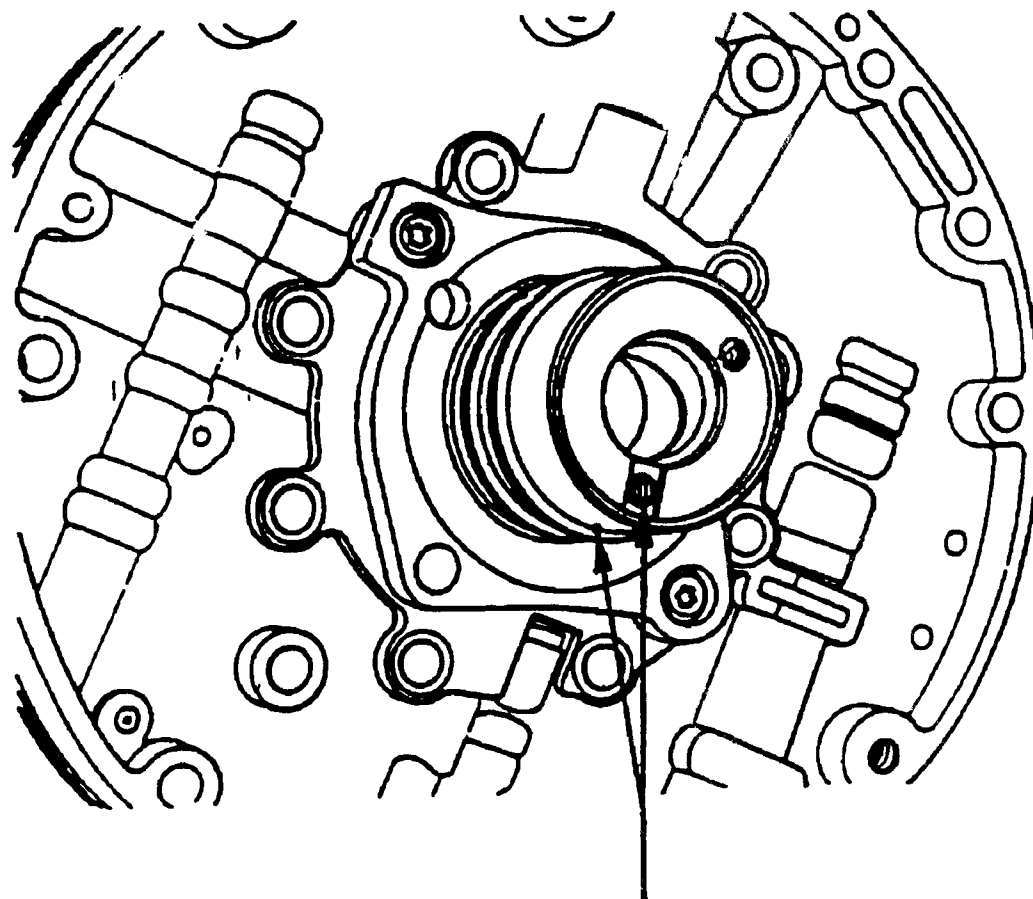
**AIR SHOULD EXIT FROM ORIFICED
CUP PLUG AND SMALL LUBE HOLE IN
FRONT OF BUSHING JOURNAL**

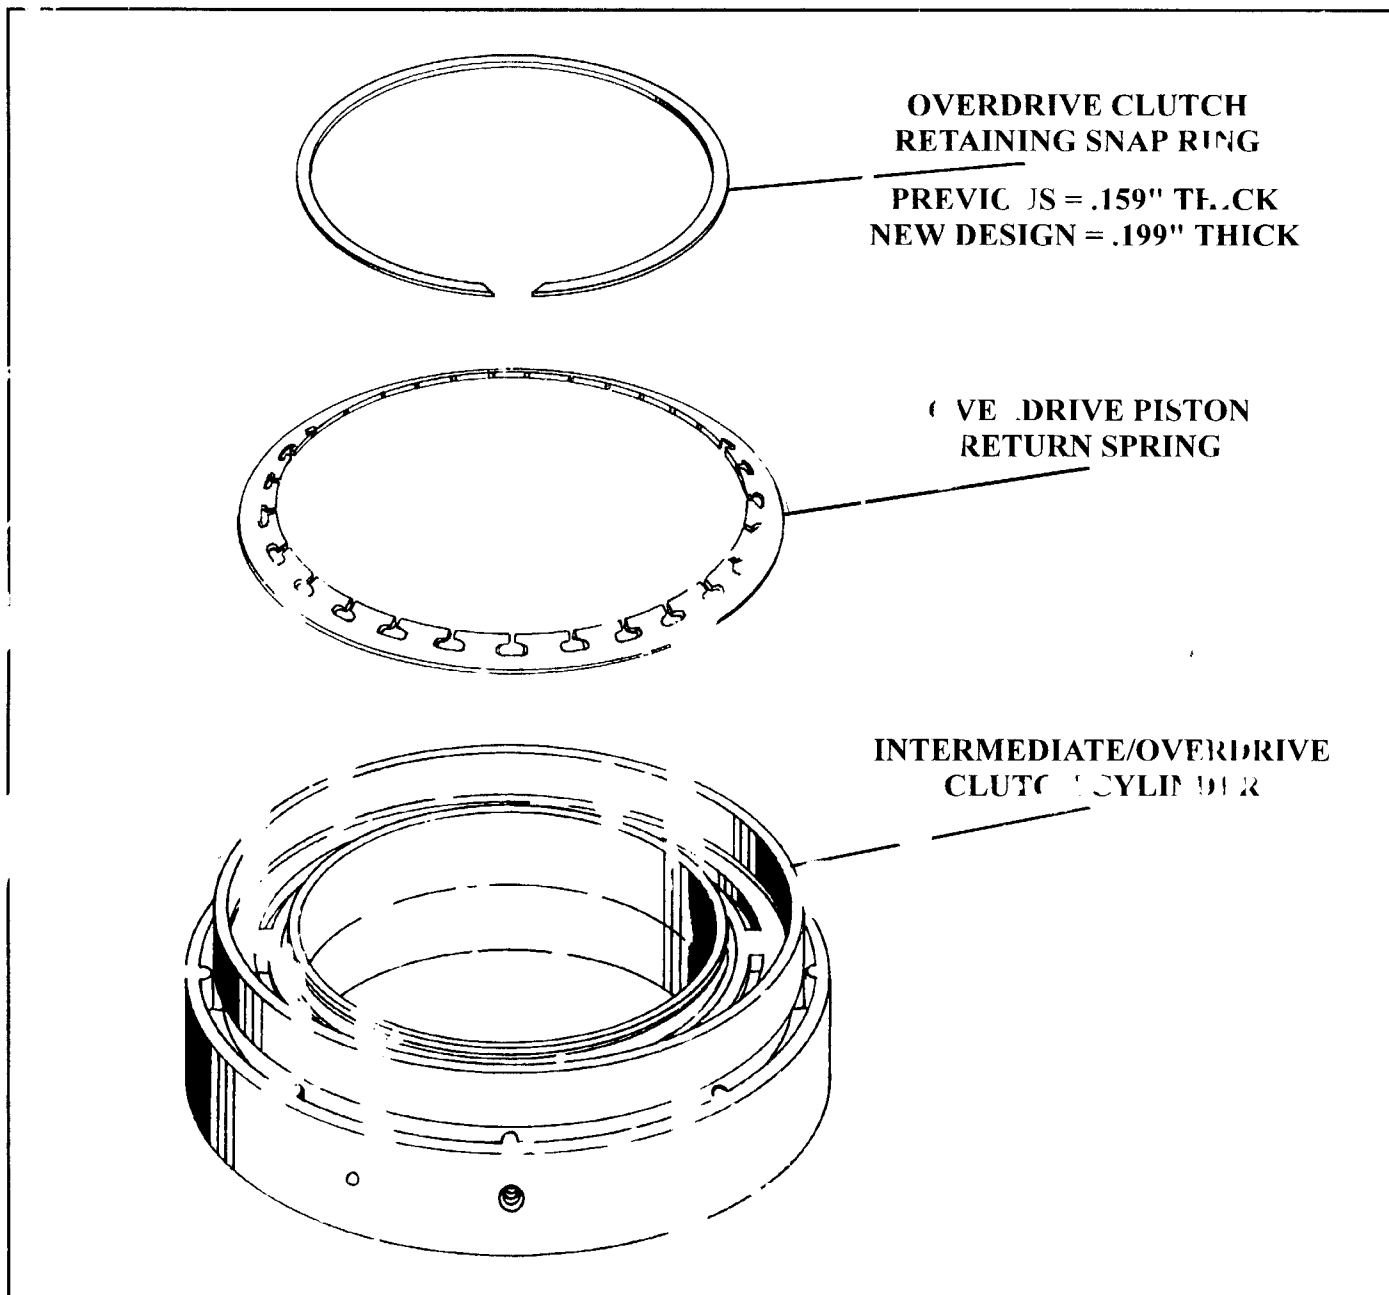
Figure 29

CAUSE: Insufficient tension on the Overdrive Clutch Snap Ring.

CORRECTION: Install a new design (Thicker) snap ring that has more tension than the previous design. The new design snap ring is .199" thick and the previous design is .159" thick, as shown in Figure 29.

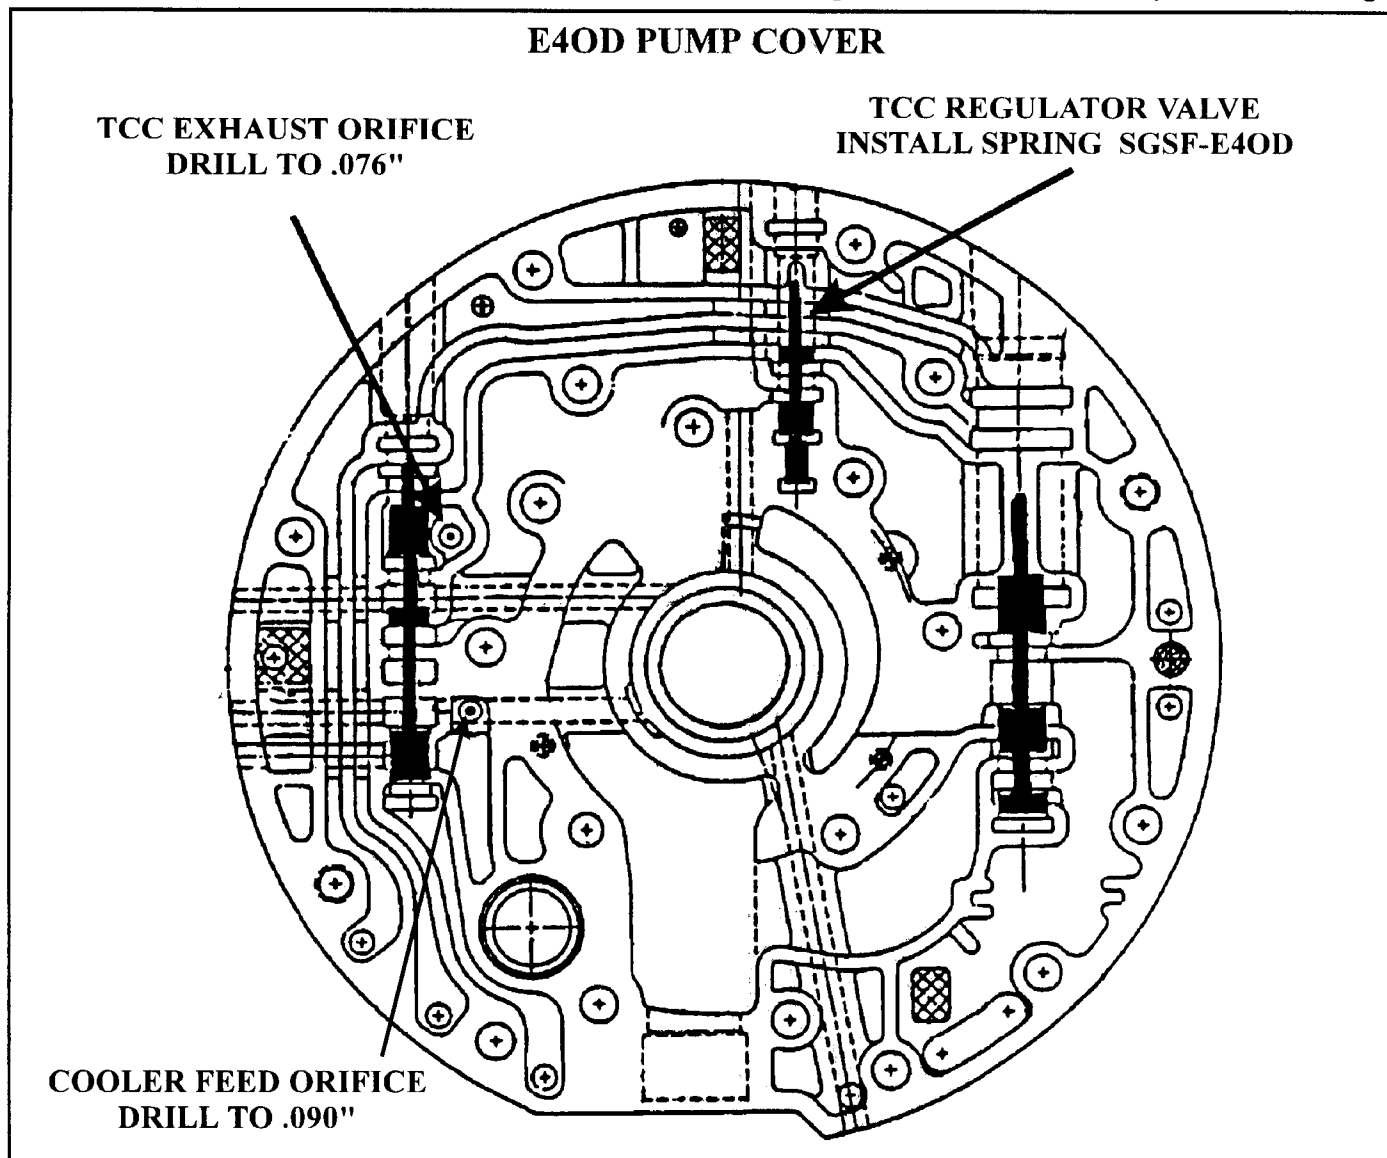
Figure 33

CAUSE: Low converter clutch apply pressure and/or converter clutch exhaust orifice too small.

CORRECTION: Replace the converter clutch regulator valve spring, located in the pump cover with a "SGSF E4OD" shudder fix spring as shown in Figure 33. Also drill the converter clutch exhaust orifice out to .076", as shown in Figure 33.

It is also recommended to drill out the cooler orifice to .090" for increased lube flow, as shown in Figure 33.

NOTE: Ford Motor Company replaced this spring with a heavier spring in 1992 and later models, so ensure the spring you are installing is *heavier* than the one you are removing.

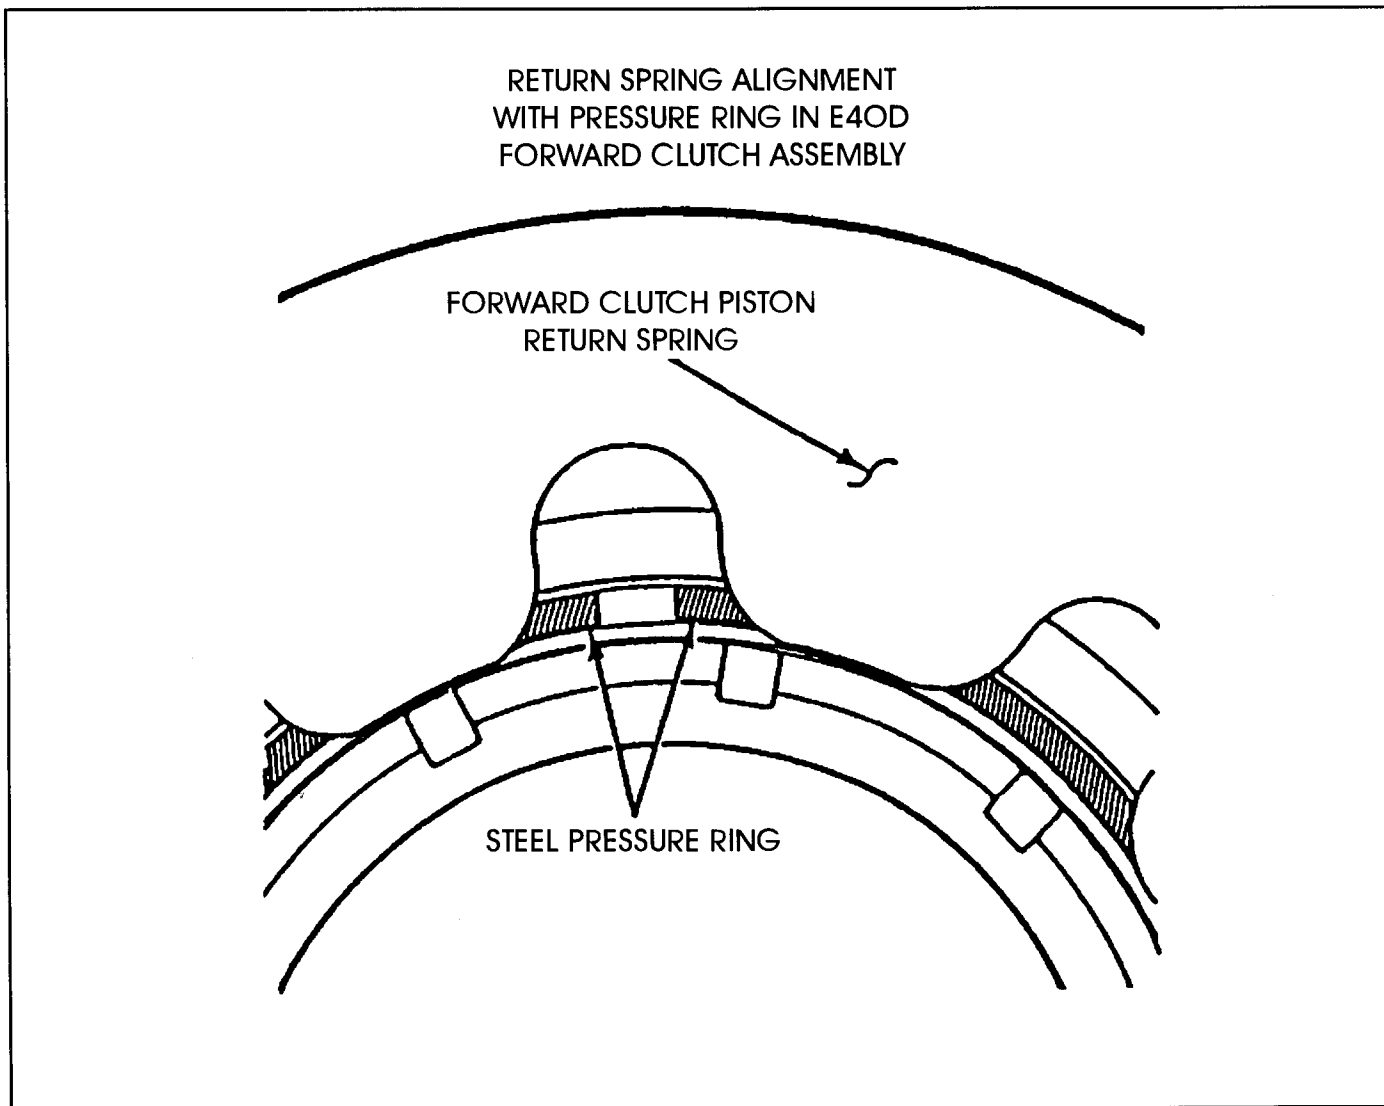
Figure 34

COMPLAINT: Forward clutch piston return spring fatigued, worn, and/or broken.

CAUSE: The cause may be, improper orientation of steel ring on top of the forward clutch piston, and the forward clutch piston return spring.

CORRECTION: Position the forward clutch piston return spring so that both ends of the steel ring are visible within the space between the two adjacent fingers of the return spring as shown in Figure 34.

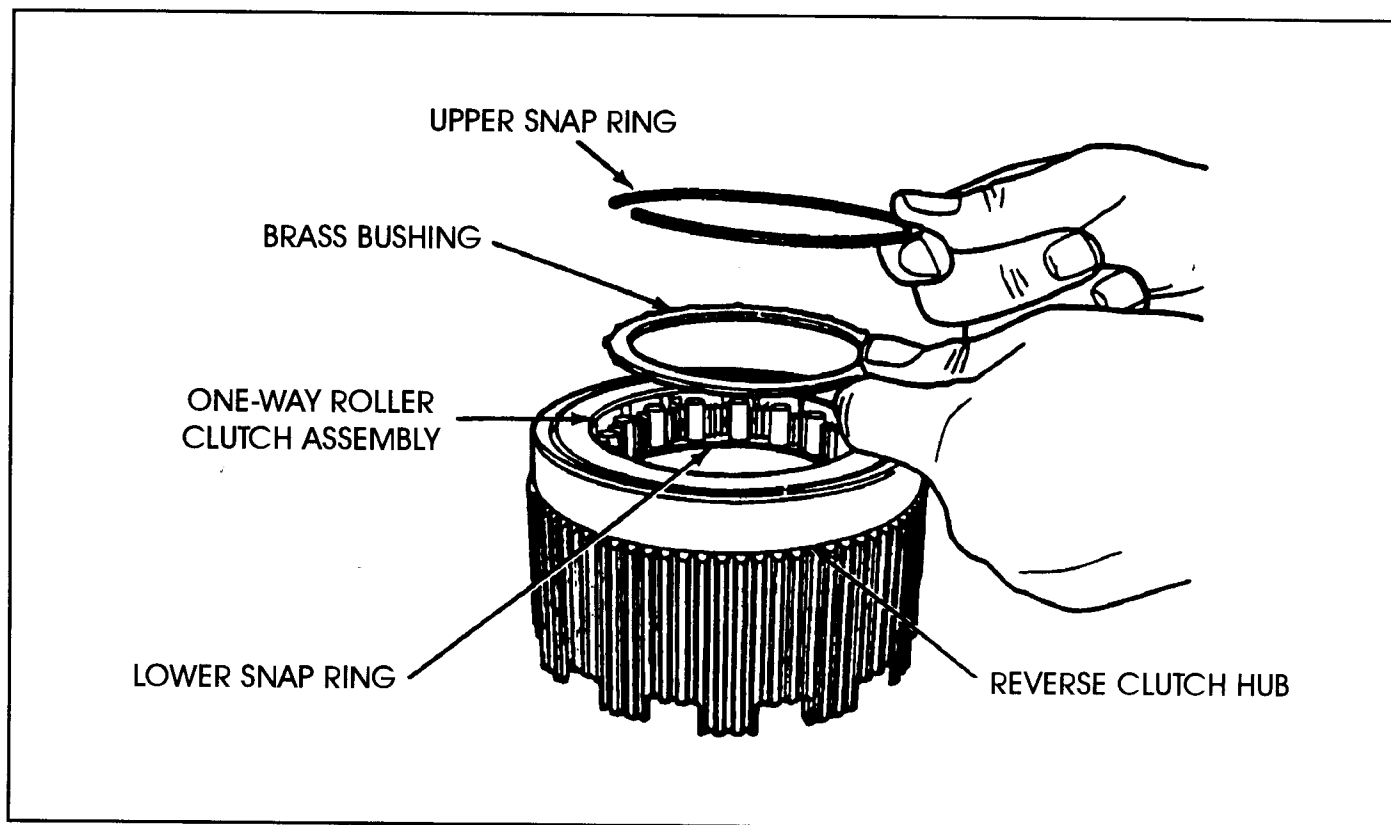
Figure 35

COMPLAINT: A no forward movement condition, until the manual shift lever is placed in the Manual Low position.

CAUSE: The cause may be, an incorrectly installed new plastic caged Low Roller Clutch Assembly, that was introduced in 1994.

CORRECTION: Use the following procedure any time the Low Roller Clutch is being replaced, using the New Plastic Caged Low Roller Clutch Assembly.

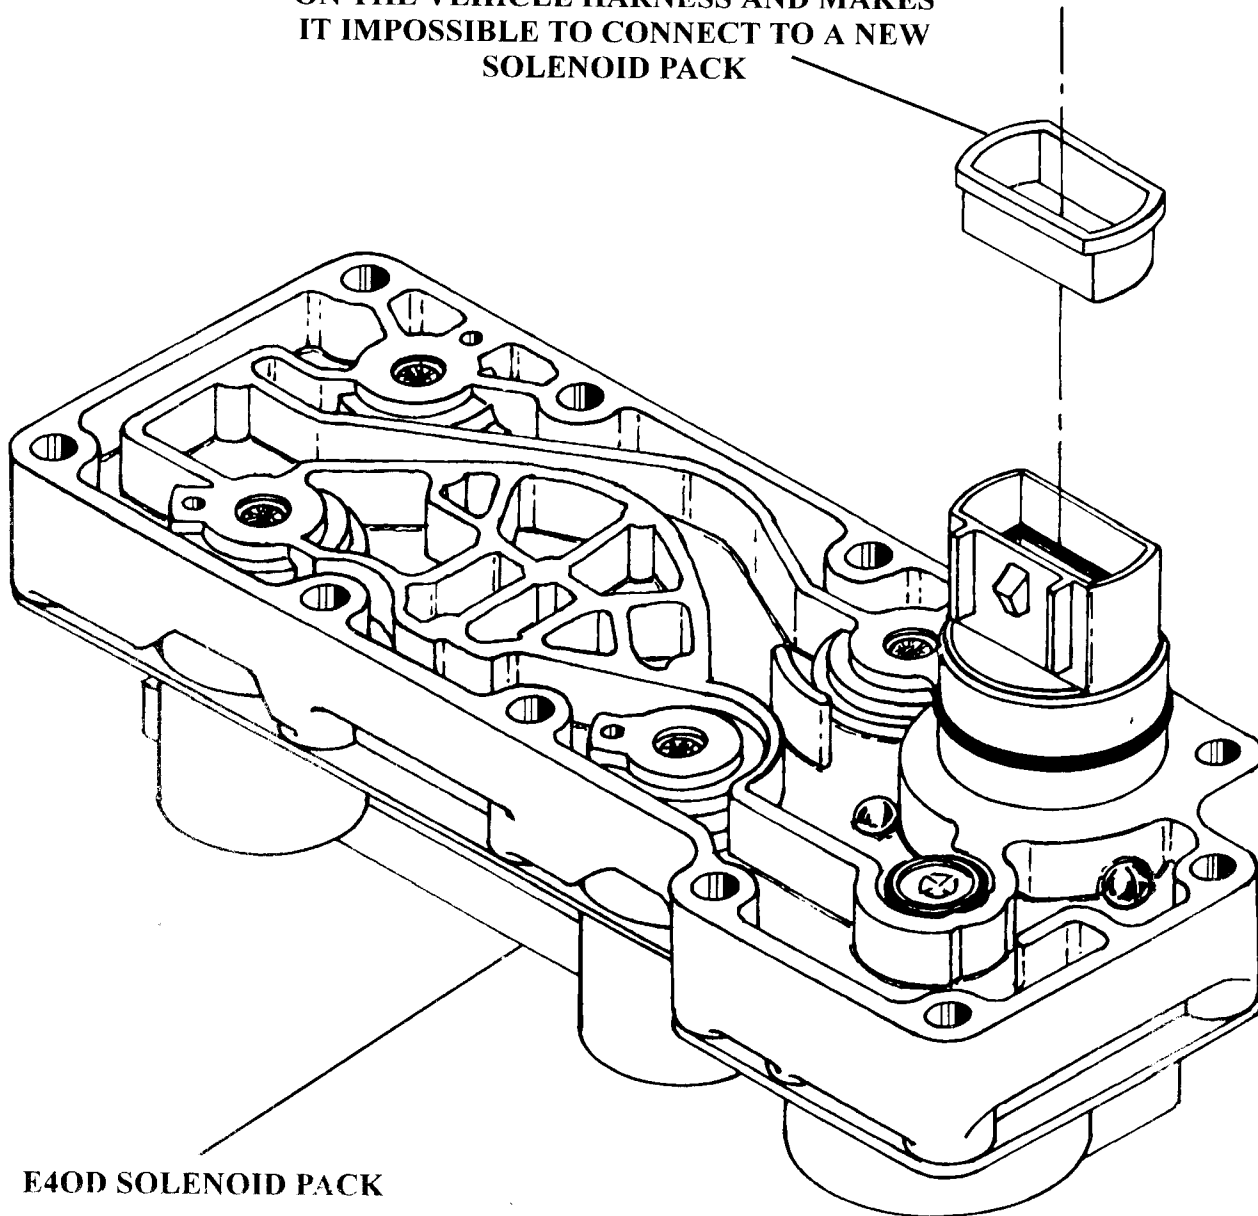
Figure 53

**PLASTIC SLEEVE SOMETIMES REMAINS
ON THE VEHICLE HARNESS AND MAKES
IT IMPOSSIBLE TO CONNECT TO A NEW
SOLENOID PACK**

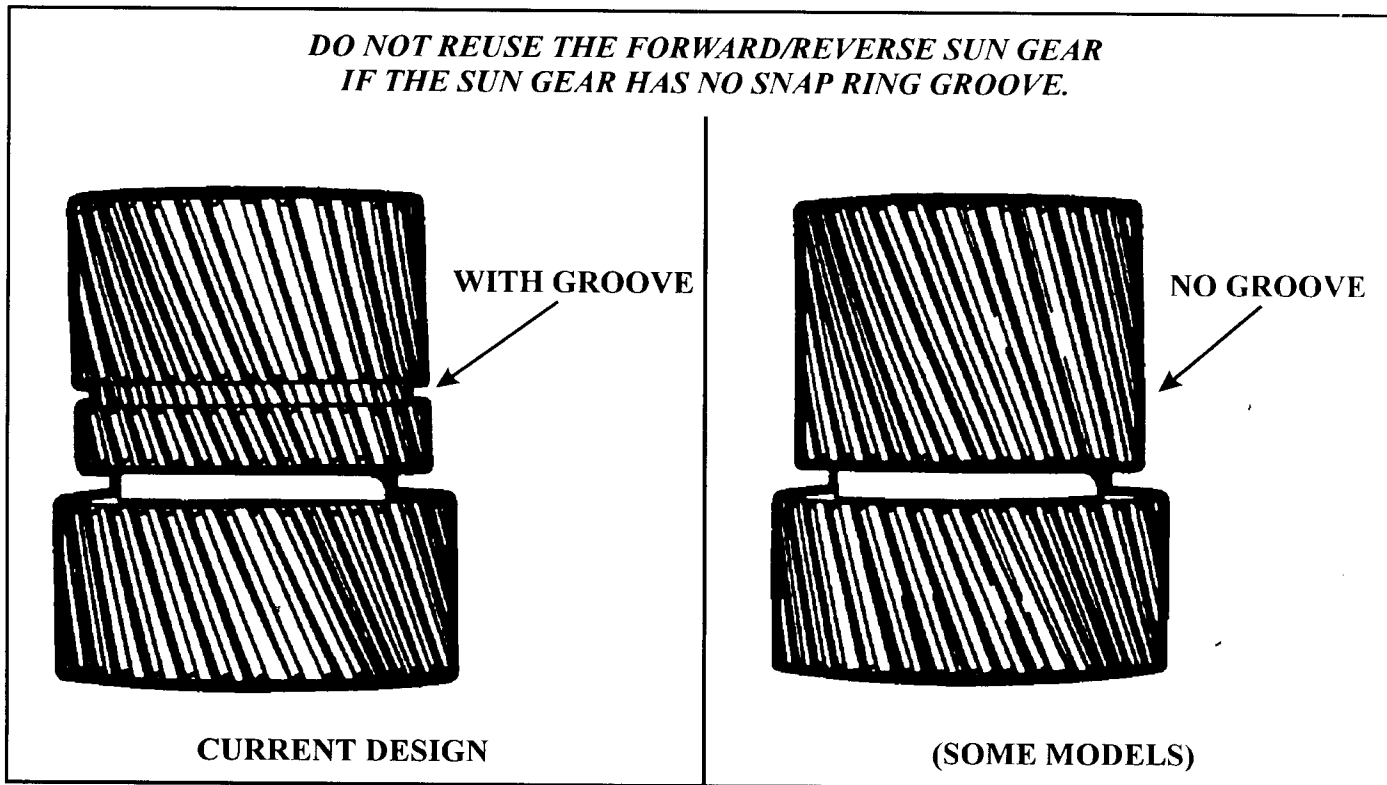
Figure 63

Some models of the E4OD transmission have been built with a Forward/Reverse Sun Gear that does not require a retaining snap ring, and has no groove for a snap ring, as shown in Figure 63. These transmissions are identified as model PRA-FA 12, serial number 00157935 thru 00158019. If internal transmission repair is required for these units, replace the Forward/Reverse Sun Gear with the current service sun gear with the snap ring groove, and the snap ring (See Figure 63).

***DO NOT REUSE THE FORWARD/REVERSE SUN GEAR
IF THE SUN GEAR HAS NO SNAP RING GROOVE.***

Forward/Reverse Sun Gear (With Groove) E9TZ-7D063-A
Retaining Snap Ring 377300-S

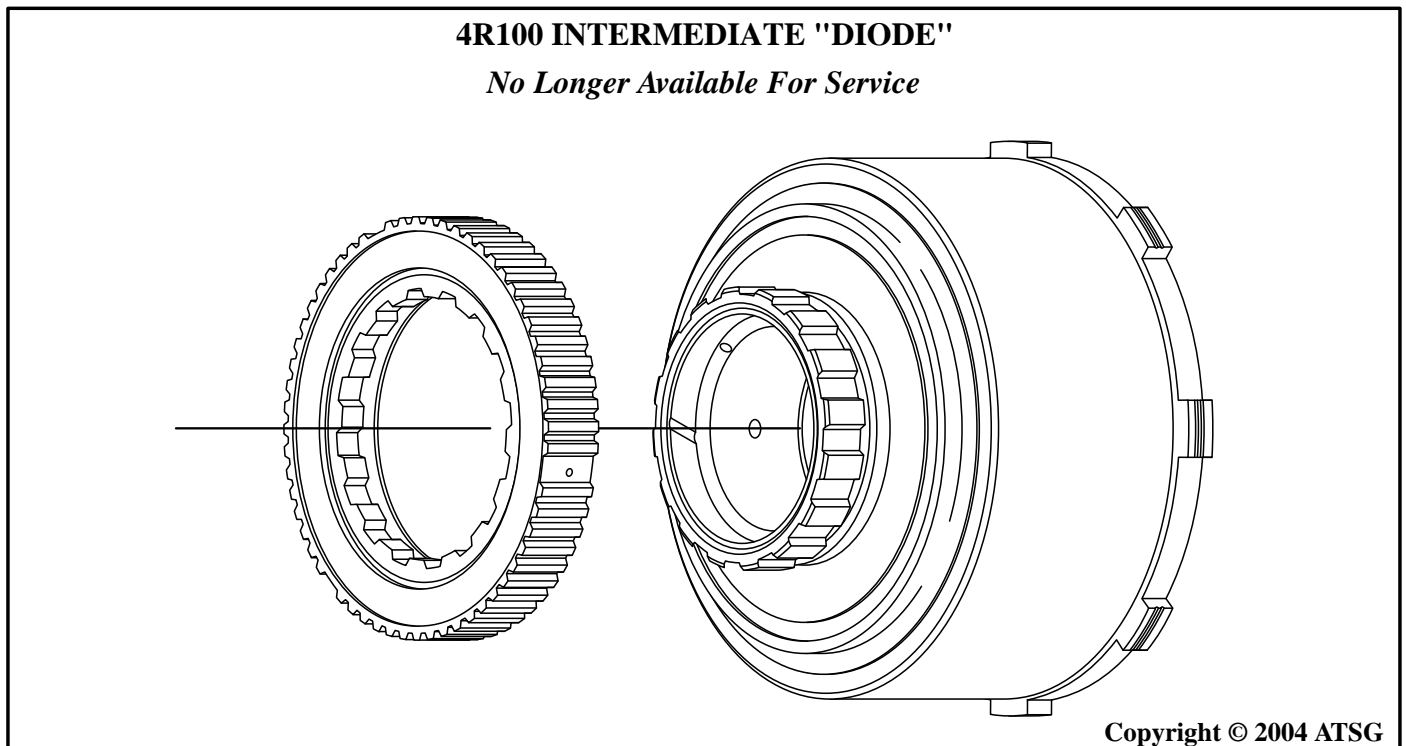
Figure 93

COMPLAINT: Some Ford Motor Company vehicles equipped with the 4R100 transmission may exhibit premature failure of the newly introduced Intermediate "Diode" Freewheel device that was installed in model year 2001 and illustrated in Figure 93.

CAUSE: The cause may be, more than expected load factors.

CORRECTION: The Intermediate "Diode" is *no longer serviced* by Ford Motor Company. The part number now supercedes to all of the previous design level parts, which include the direct clutch housing, intermediate sprag assembly, outer race to direct drum thrust washer, and the intermediate friction plates. All of the previous design level parts are illustrated in Figure 94, with the OEM part numbers. The intermediate frictions must be replaced because the tooth count on the outer race between the diode and the sprag are different.

Special Note: ATSG recommends replacing the Intermediate "Diode" during service, even if it has not yet failed, to protect yourself from possible future failures.
