## NO.3 WIRE FRAME REPLACEMENT

650MI-01

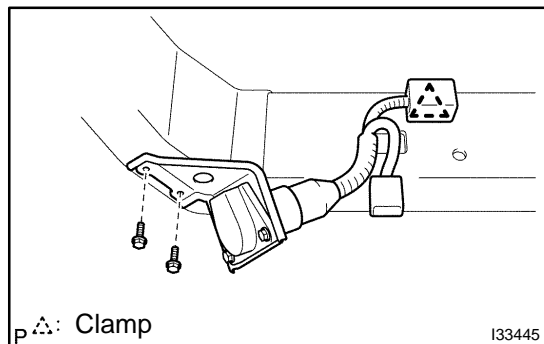
### 1. REMOVE NO.3 WIRE FRAME

- (a) Disconnect the connector.
- (b) Release the clamp and remove the 2 bolts and No.3 wire frame.
