FORD E40D "UPDATE HANDBOOK"

INTRODUCTION FORD E4OD "UPDATE HANDBOOK"

**FORD E40D
VALVE BODY, SPACER PLATE, SPACER PLATE GASKETS,
CHECKBALL LOCATIONS, AND CASE CHANGES,
FOR THE 1996 MODEL YEAR**

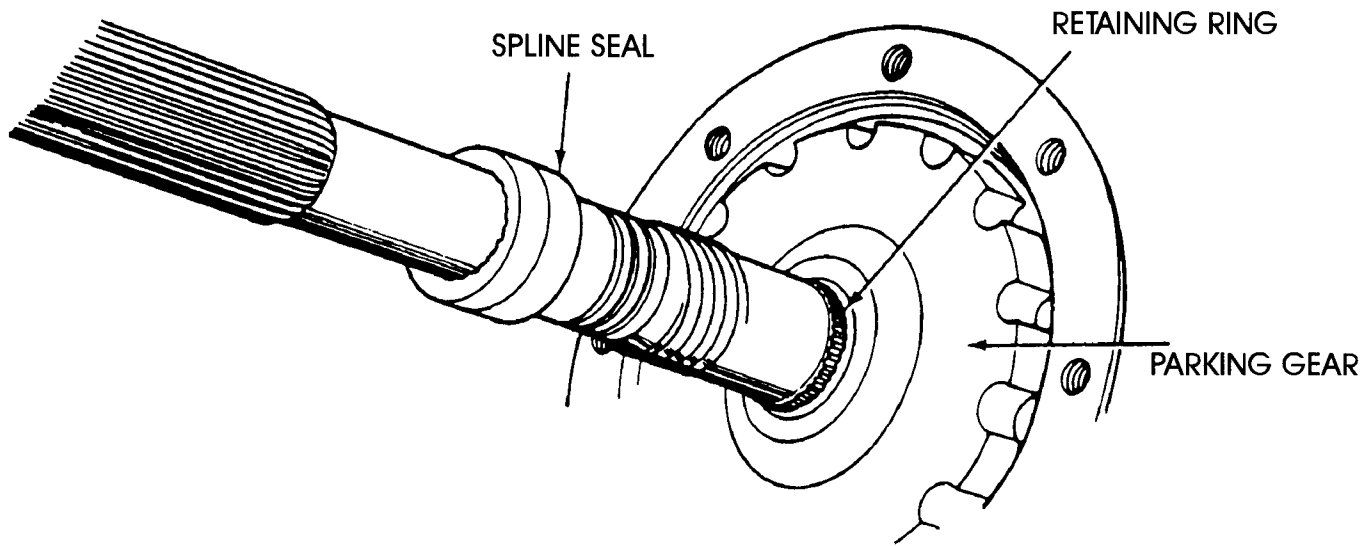
Figure 22

CAUSE: The cause may be a broken snap ring on the output shaft, allowing the parking gear to move rearward, and then the parking pawl cannot engage into the parking gear. Refer to Figure 22.

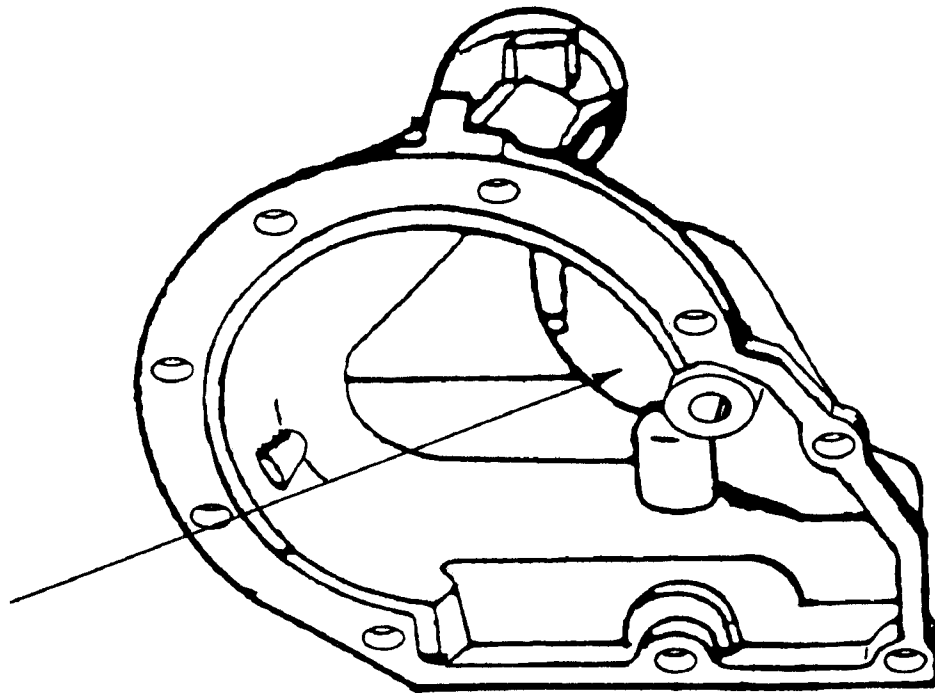
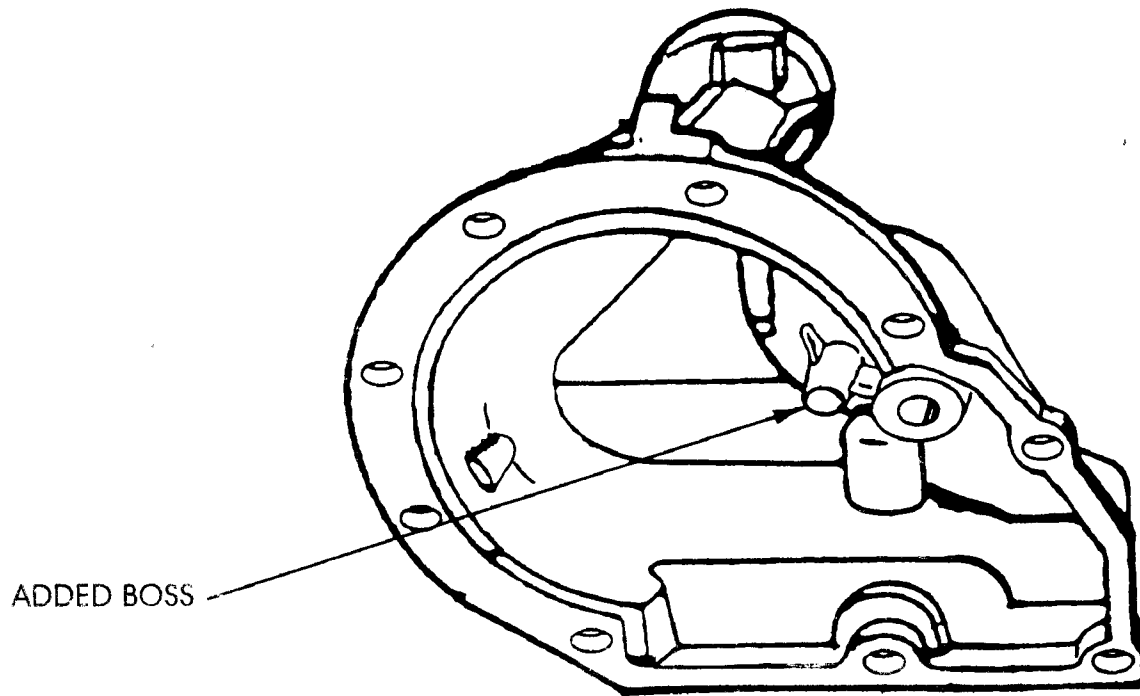
Figure 24

NEW DESIGN

CORRECTION: There is now available a new service package, under OEM part number F0TZ-7A040-A, that includes a new design extension housing with a new "Boss" cast into it to prevent the parking gear from moving rearward in case the snap ring breaks (See Figure 24). The service package also includes a new "*high strength*" snap ring, and a snap ring installation aid, as shown in Figure 25.

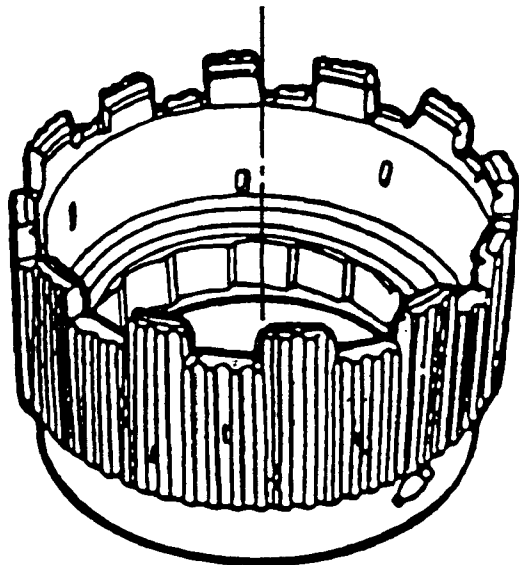
***"INCORRECTLY"
INSTALLED***

CAUTION

IF THE ROLLER CLUTCH IS INSTALLED IN THIS DIRECTION, THE REVERSE HUB WILL FREEWHEEL IN BOTH DIRECTIONS.

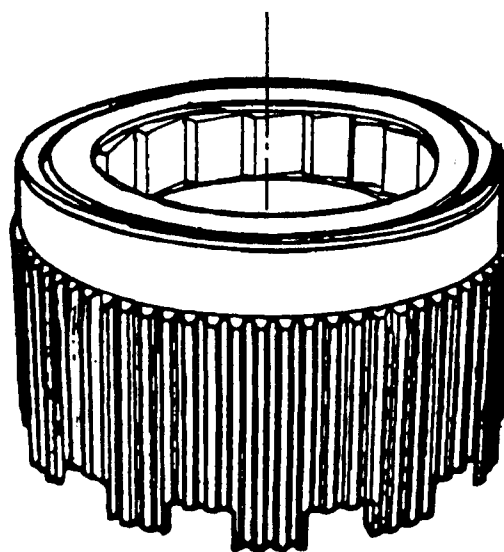
***"CORRECT"
INSTALLATION***

DISCARD BOTH SNAP RINGS. THEY ARE NOT USED WITH THE PLASTIC ROLLER CLUTCH

- (1) Remove the upper snap ring, brass bushing, roller clutch assembly, and the lower snap ring, as shown in Figure 35. *Discard all parts removed!*
- (2) Install the New Plastic Cage Low Roller Clutch Assembly through the *rear* side of the Reverse Clutch Hub, with the tabs on the rear edge. Seat the Low Roller Clutch into the Reverse Clutch Hub, and rotate clockwise to seat rollers and lock tabs in place. Refer to Figure 36 for proper installation.

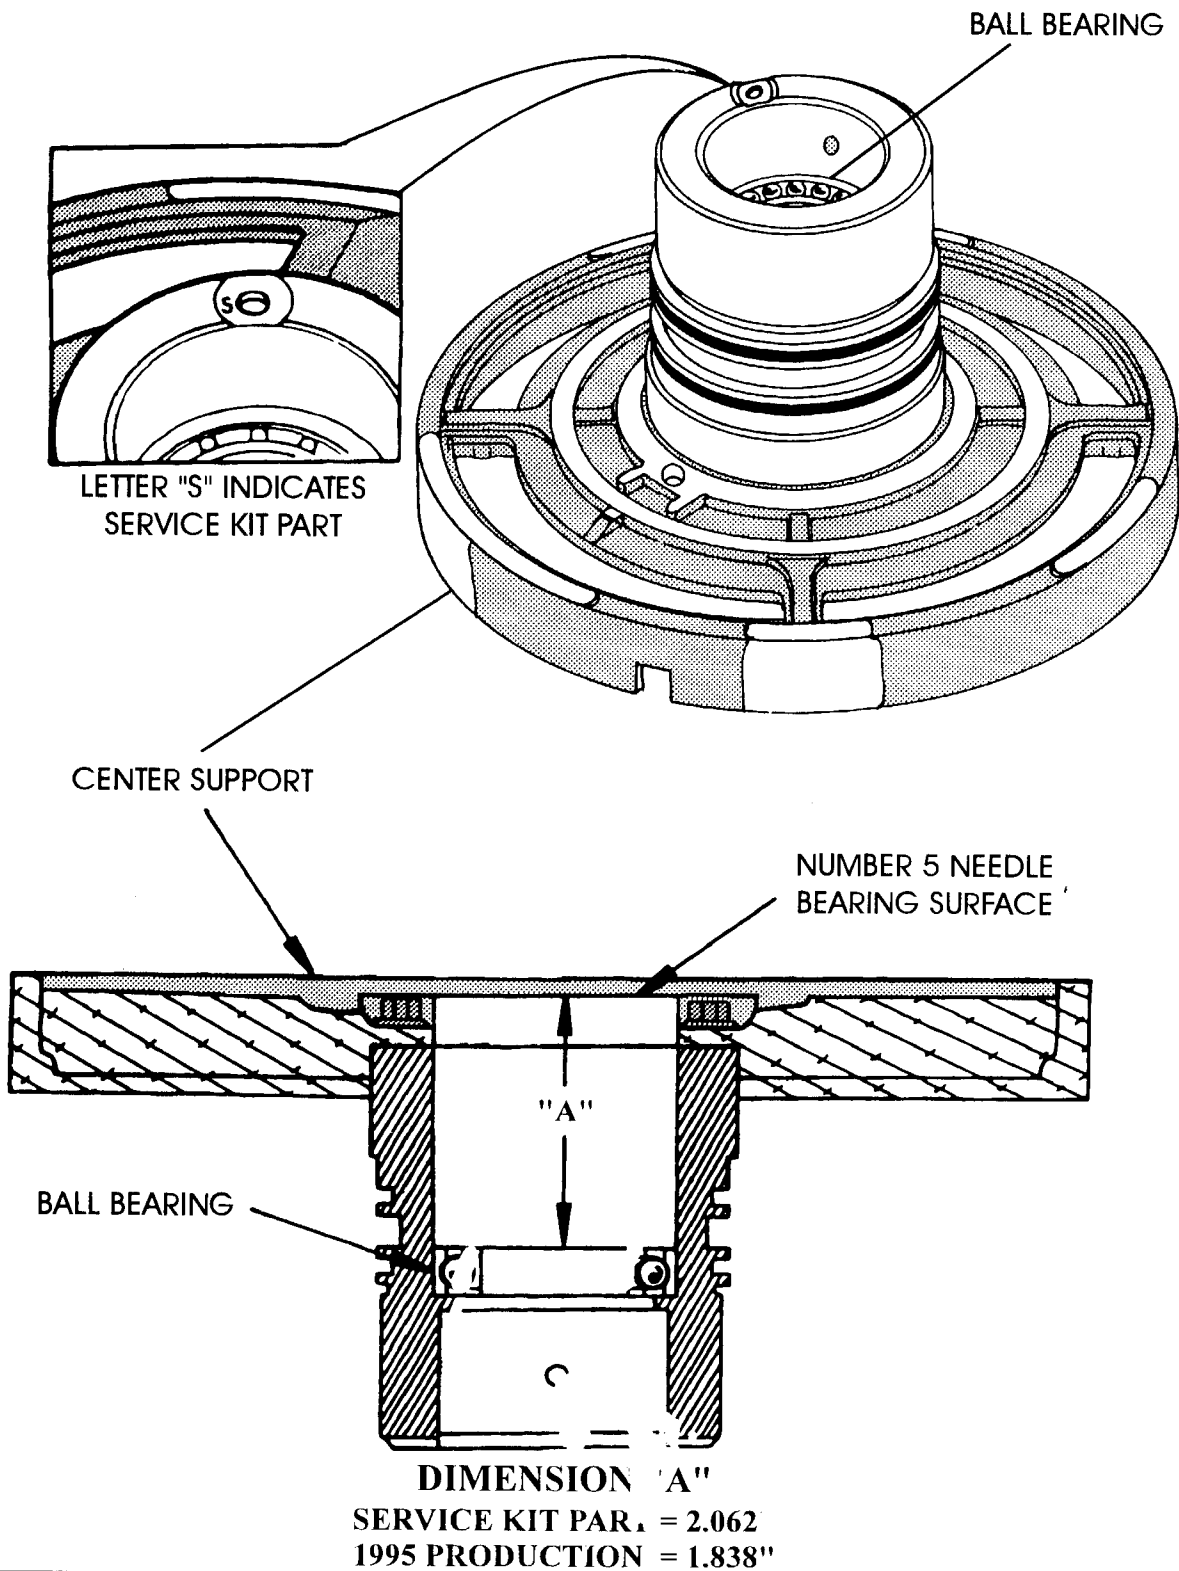
Figure 44
AUTOMATIC TRANSMISSION SERVICE GROUP

- (2) The parts in this Service Kit are different dimensions than 1995 model year production parts and *will not* interchange with 1995 model parts (See Figures 44 and 45).

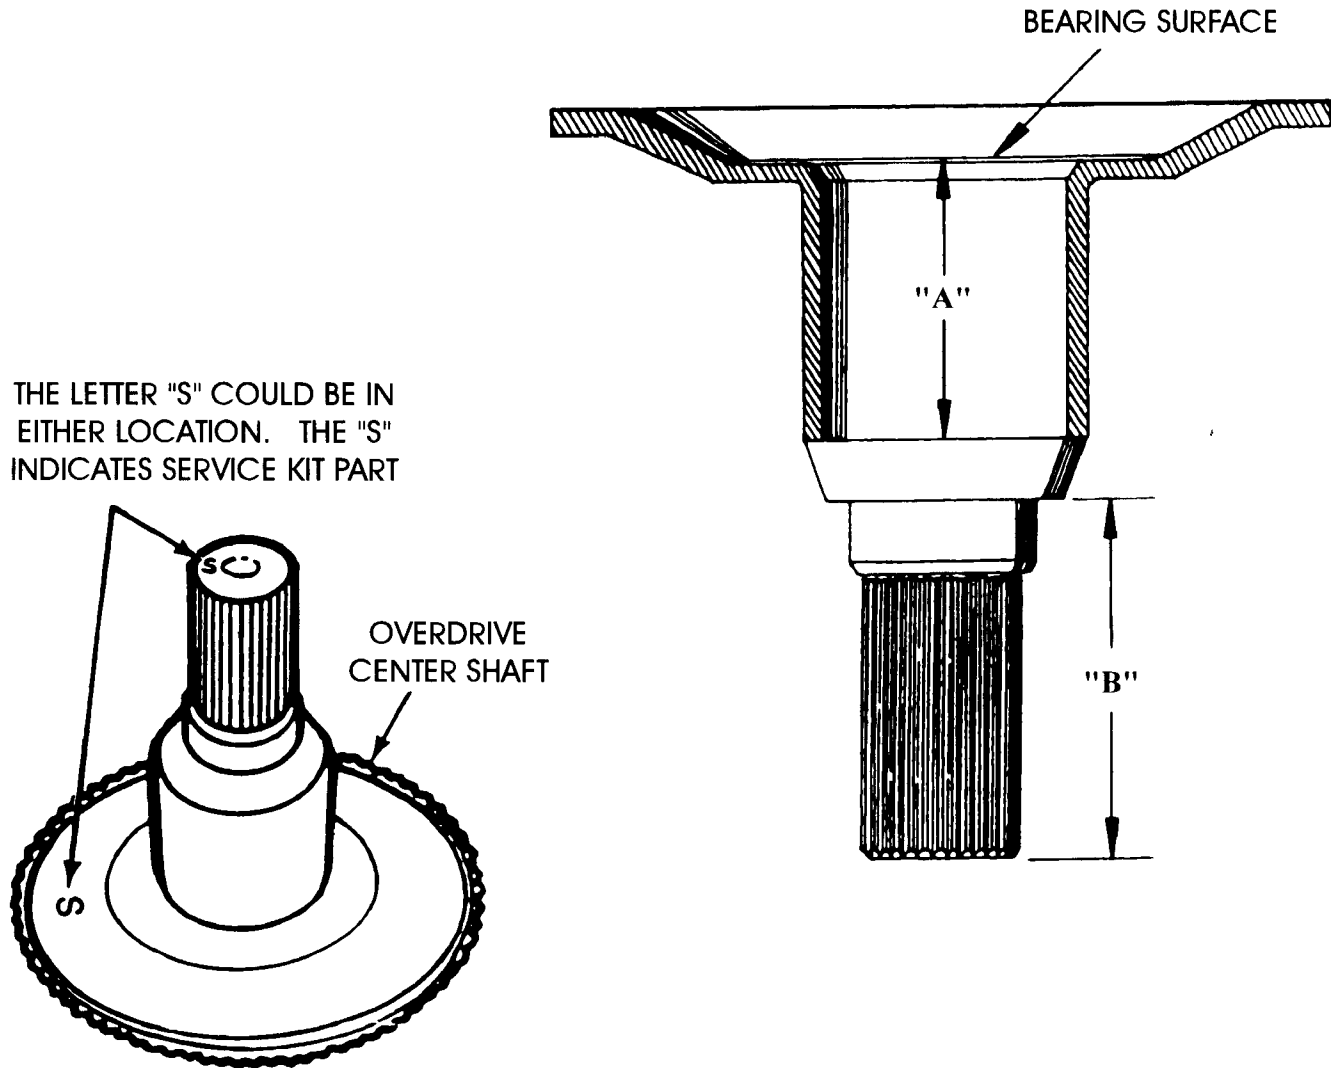
Figure 45

THE LETTER "S" COULD BE IN EITHER LOCATION. THE "S" INDICATES SERVICE KIT PART

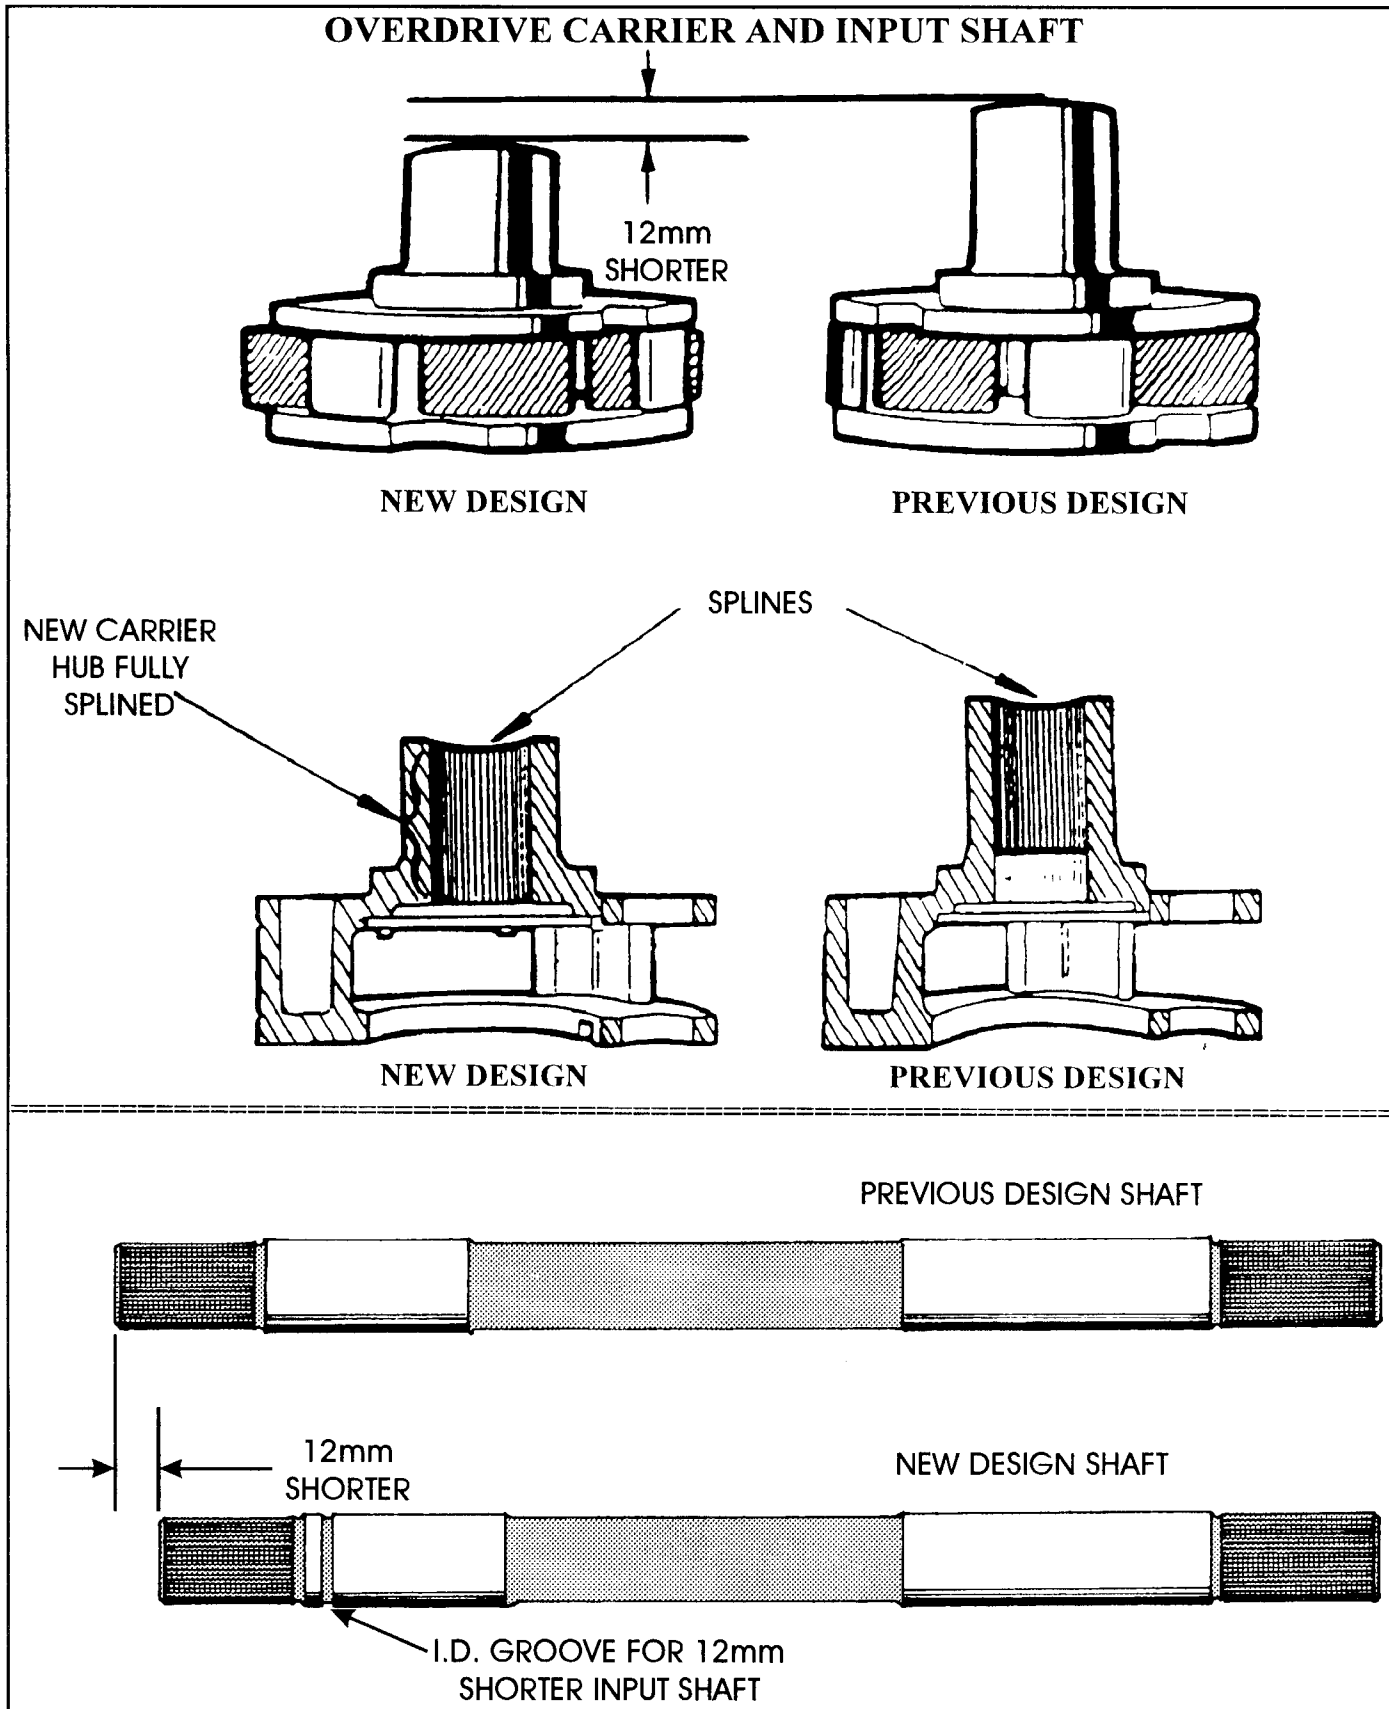
Figure 48
AUTOMATIC TRANSMISSION SERVICE GROUP

- (2) OVERDRIVE CENTER SHAFT - Different machining dimensions on the center shaft to accommodate the added ball bearing, and the pilot on the center shaft has been removed. The new design Overdrive Center Shaft can be identified as a "Service Part", by the letter "S" stamped on the shaft in one of two locations, as shown in Figure 45. The Service Kit Overdrive Center Shaft has different dimensions than 1995 model year production center shaft. Refer to Dimensions "A" and "B" in the cutaway drawing shown in Figure 45.
Special Note: There is also an updated Overdrive Carrier and Input Shaft, available under OEM part number F4TZ-7B446-B, to help improve durability. Both pieces have different dimensions than the previous parts, as shown in Figure 48. The new overdrive carrier hub is 12mm (.472") shorter than the previous models, and the internal splines now run the full length of the hub which makes it stronger. The Input Shaft is also 12mm (.472") shorter than the previous models, to accommodate the new overdrive carrier, and has an I.D. groove cut in the shaft for identification (See Figure 48).

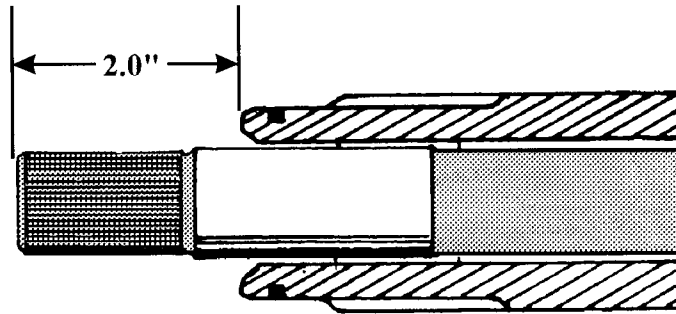
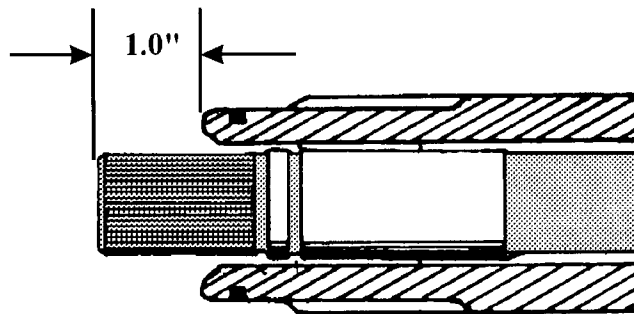
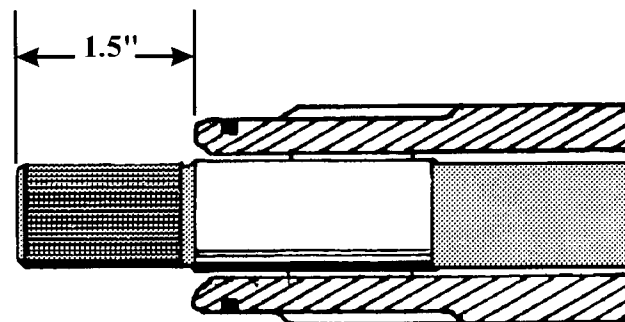
Figure 49

"INCORRECT"

PREVIOUS (LONG) INPUT SHAFT USED
WITH NEW DESIGN OVERDRIVE CARRIER

NEW DESIGN (SHORT) INPUT SHAFT USED
WITH PREVIOUS DESIGN OVERDRIVE CARRIER

THE INPUT SHAFT MUST EXTEND 1.5" PAST THE END OF THE PUMP STATOR
IF THE CORRECT INPUT SHAFT AND OVERDRIVE CARRIER WERE USED

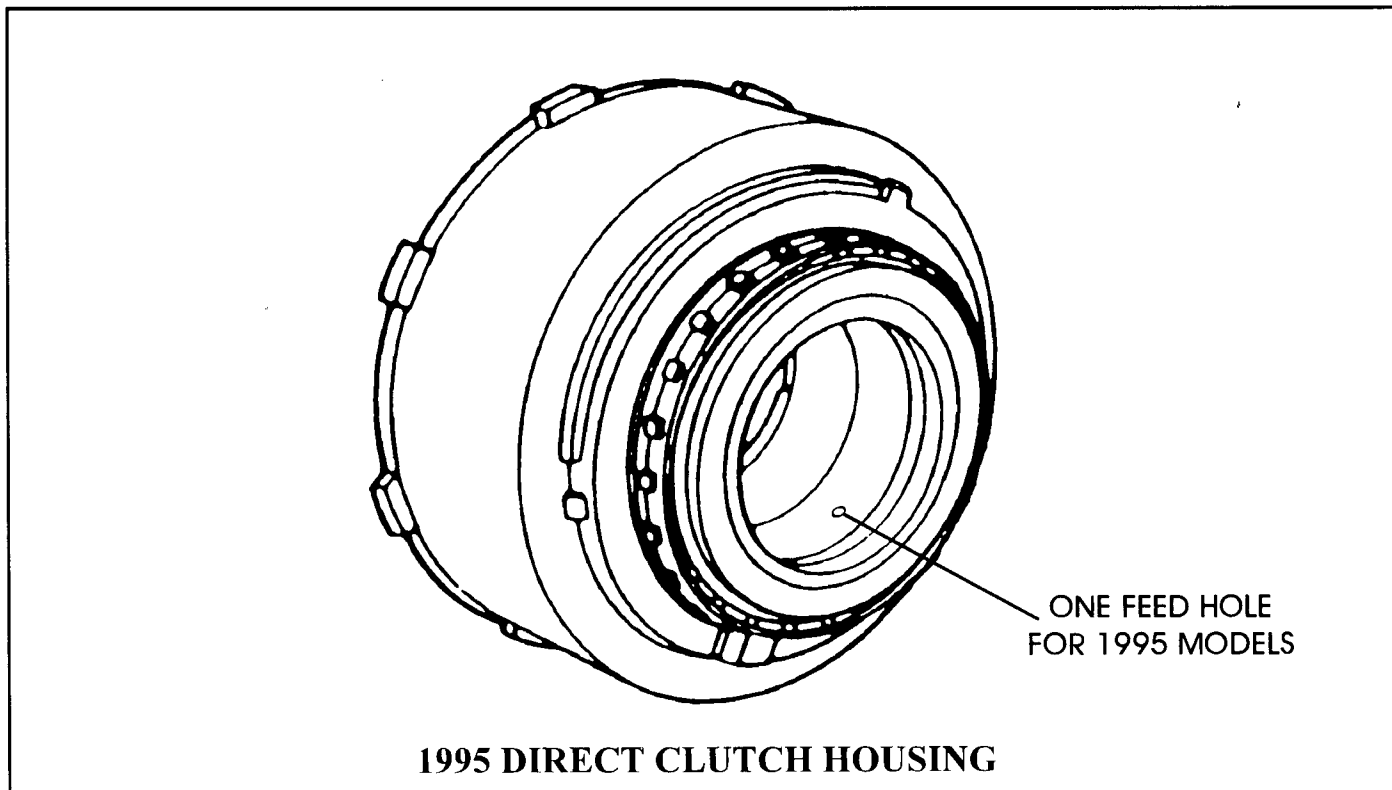
Figure 51

CHANGE: Beginning at the start of production for the 1995 model year, all E4OD transmissions were built with a revised Direct Clutch Housing (Intermediate Brake Drum) as shown in Figure 51.

(1) DIRECT CLUTCH HOUSING - 1995 models now have only *one* direct clutch apply pressure feed hole, instead of the *two* feed holes found in previous models (See Figure 51).

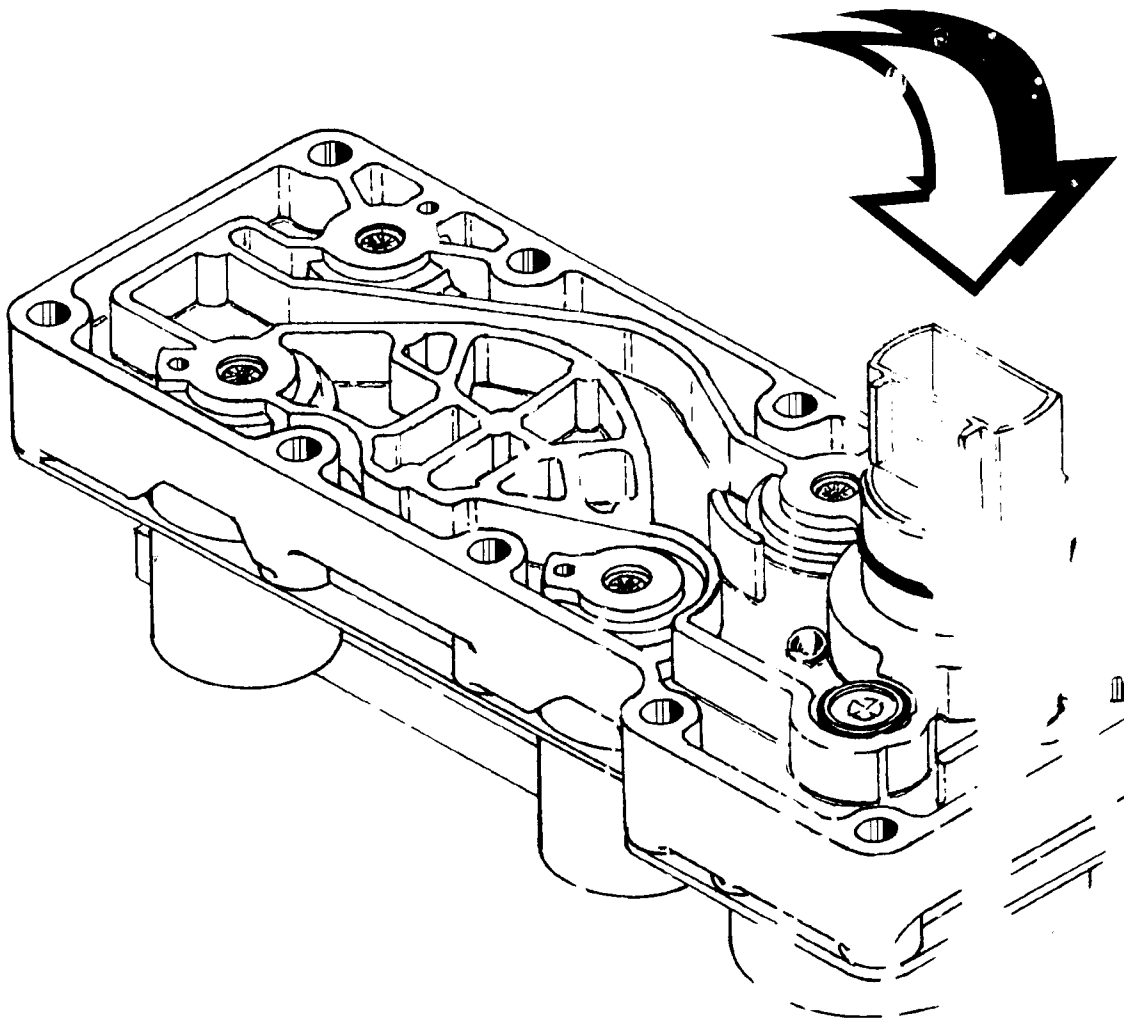
- (1) **SOLENOID PACK** - New design solenoid assembly case connector to accommodate the new design vehicle harness connector. Refer to Figure 52 for identification of the previous design and the new design solenoid assemblies.

NOTE: The plastic sleeve incorporated in the previous design solenoid pack has been eliminated on the new design solenoid pack (See Figures 52 and 53). This plastic sleeve will sometimes remain on the vehicle harness connector when it is disconnected. If a new solenoid pack is installed (which includes sleeve), it will be impossible to reconnect the vehicle harness to the solenoid pack until the old sleeve is removed from vehicle harness connector. Refer to Figure 53.

THERE IS NO SLEEVE ON 1995 SOLENOID PACK

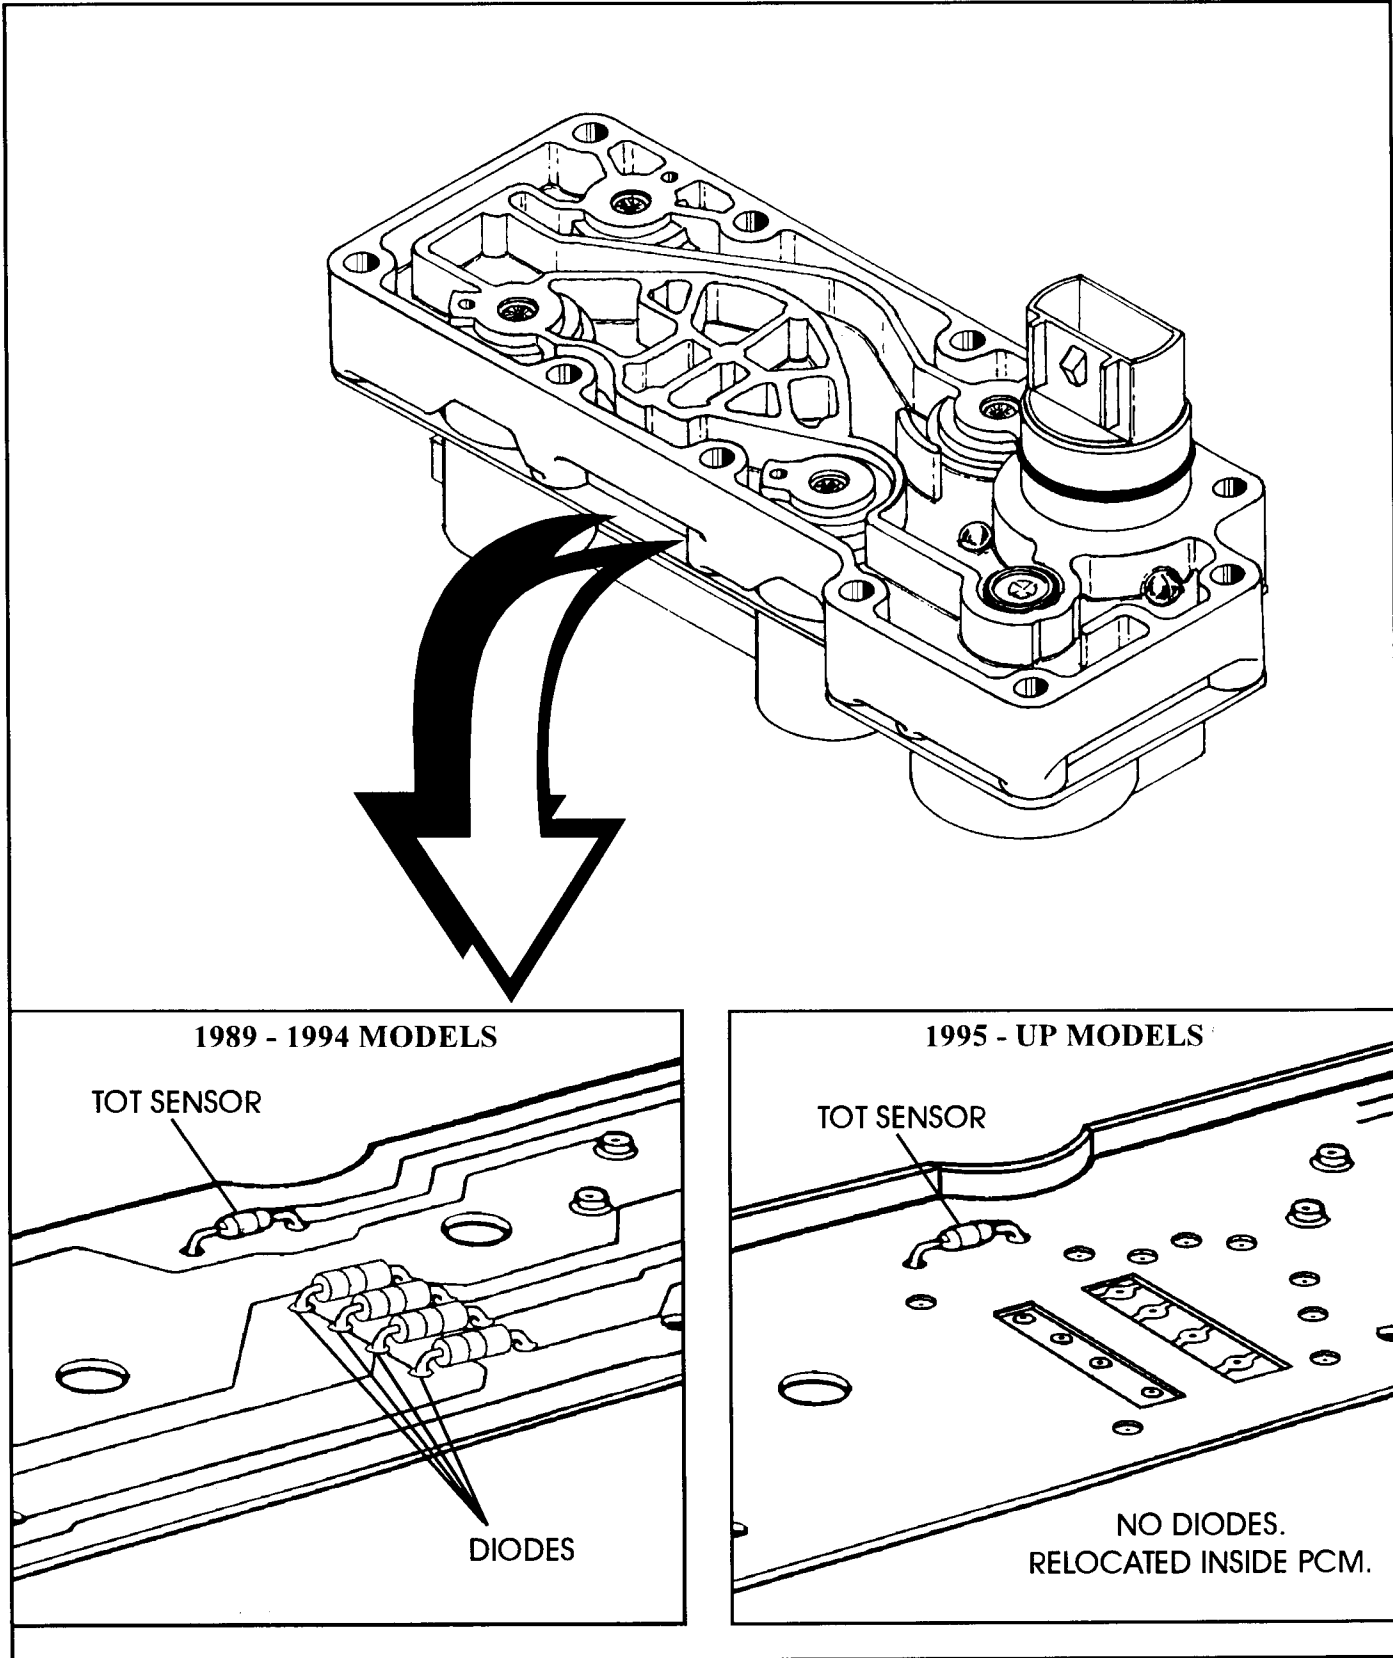
Figure 54

CHANGE: Beginning at the start of production for 1995, all models of the E4OD transmission were produced using a new design solenoid pack, that will not interchange with previous models, as the internal diodes have been eliminated and put into the PCM (See Figure 54)

They will not interchange because in 1995 models the diodes for the solenoids were moved out of the solenoid pack and placed into the PCM (See Figure 54).

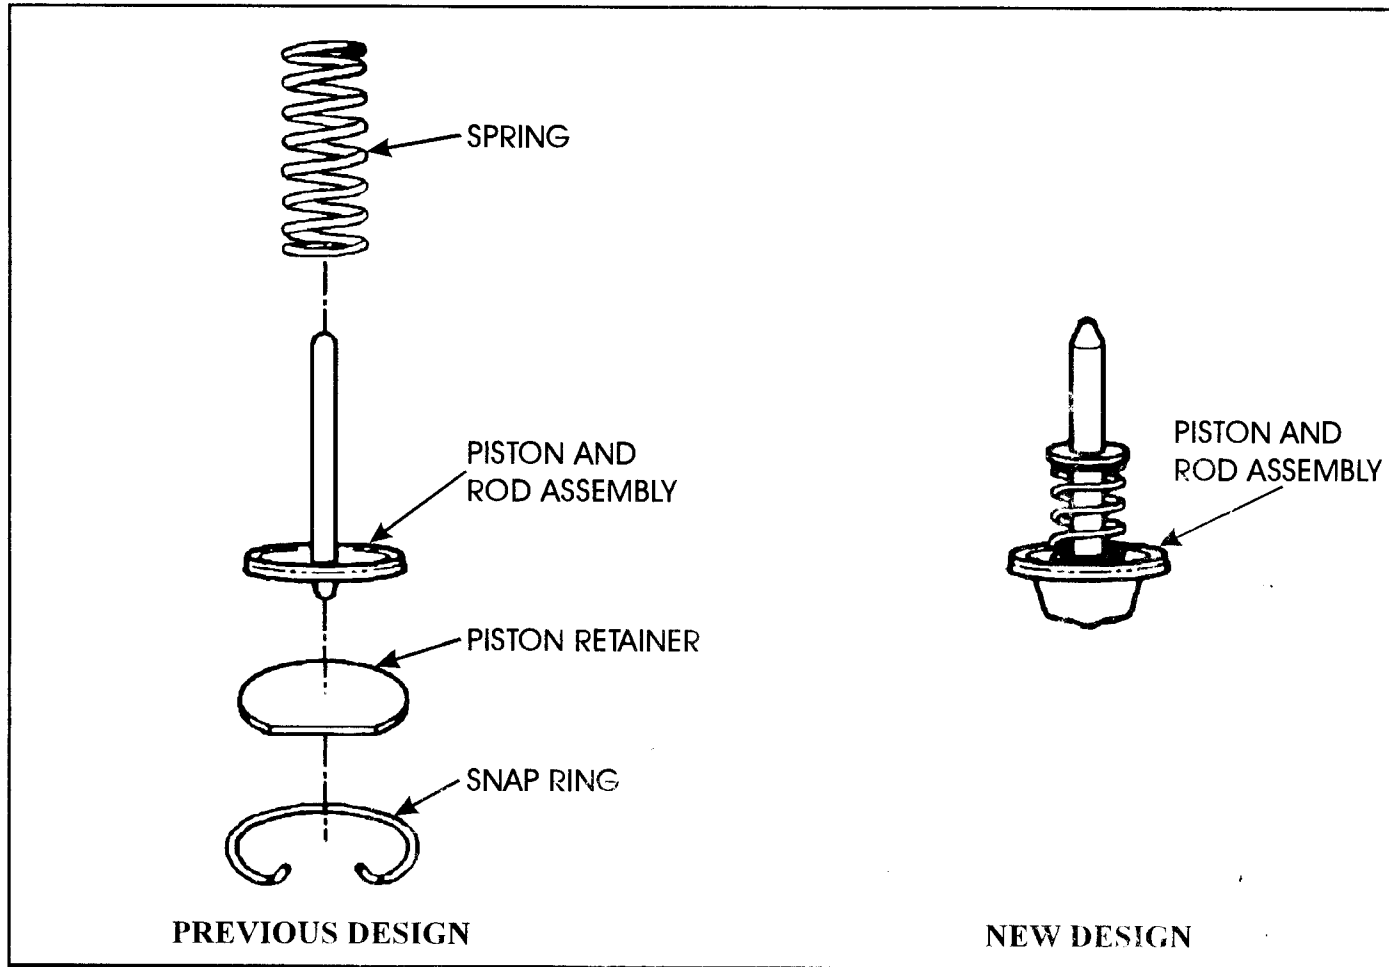
Figure 61

CHANGE: Beginning on August 8, 1995, all 1996 model E4OD transmissions were produced with a new design Intermediate Band Apply Servo Assembly (See Figure 61).

- (1) INTERMEDIATE SERVO PISTON - Total change in design, as shown in Figure 61.
- (2) SERVO PISTON RETAINER - Eliminated, as shown in Figure 61.
- (3) RETAINING SNAP RING - Eliminated, as shown in Figure 61.
- (4) TRANSMISSION CASE - Snap ring groove in the case piston bore was eliminated, as it was no longer need (See Figure 62).

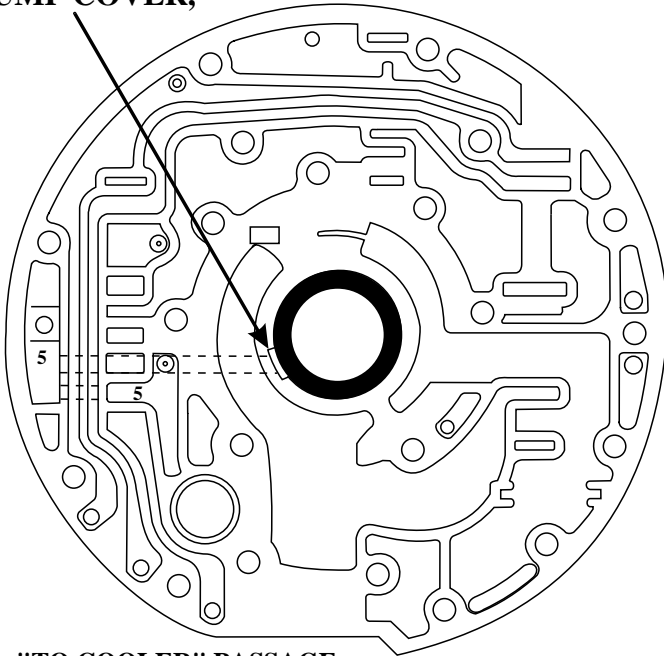
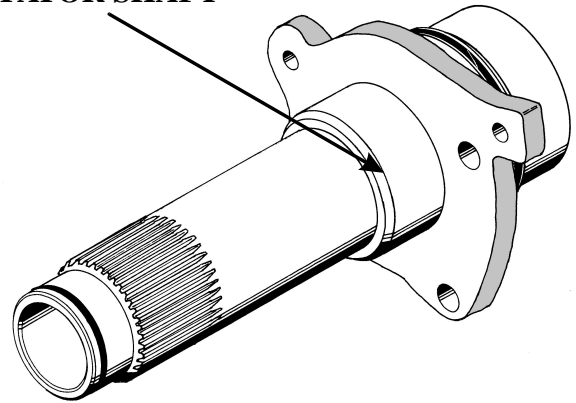
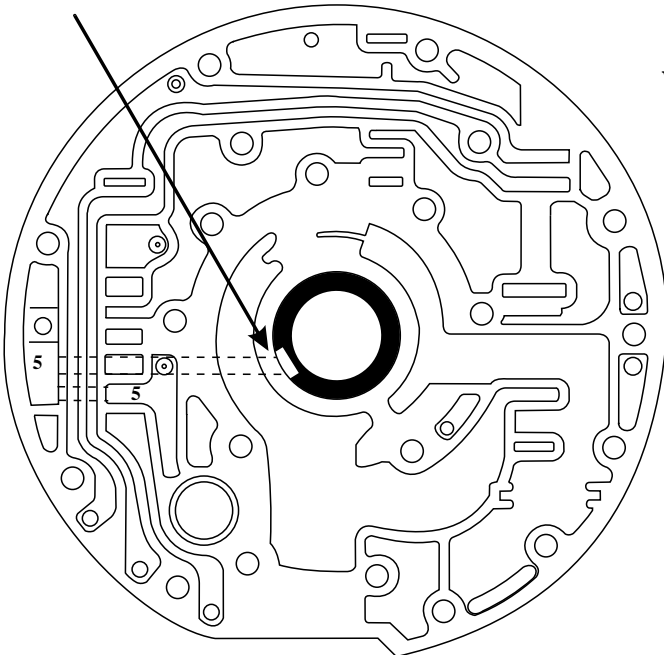
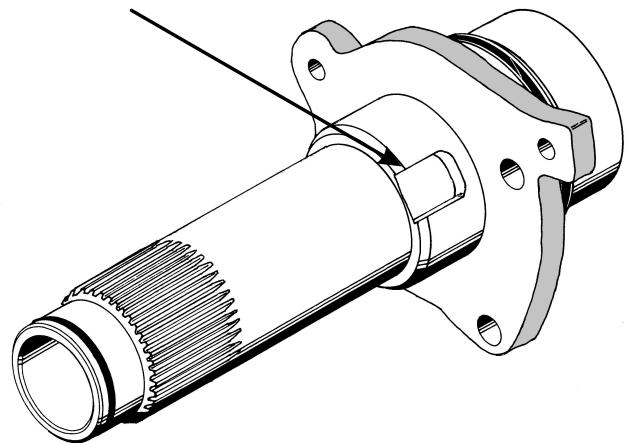
Figure 67
AUTOMATIC TRANSMISSION SERVICE GROUP

COMPLAINT: After rebuild, your E4OD transmission is returned with premature planetary failure due to a lack of lubrication, *or* if you checked lube flow before delivery, you find zero lube flow, and zero flow from the front "To Cooler" fitting.

CAUSE: The cause may be, mis-match of stator shaft and pump cover creating a *totally blocked* "To Cooler" passage in the pump cover.

- (1) **89-94 MODELS** - Have a relief (Notch) cut into the *pump cover* on the inside diameter, where the stator shaft presses into the cover, creating a passage for converter apply oil to get into the "To Cooler" passage in the pump cover. Refer to Figure 67.
- (2) **95-96 MODELS** - The relief (Notch) cut in the pump cover was eliminated from the cover, and the relief (Notch) cut was added to the *stator shaft* (See Figure 67).
- (3) If for any reason, it becomes necessary to install a different stator shaft into your pump cover, you *must* ensure that you are installing compatible parts.

89-94 Model pump cover *with notch*, **MUST** be used with the stator shaft *without notch*. Refer to Figure 67.

95-96 Model pump cover *without notch*, **MUST** be used with the stator shaft *with notch*. Refer to Figure 67.

If you install a 89-94 stator shaft *without notch*, into a 95-96 pump cover *without notch* -- You will create a *totally blocked "To Cooler" passage* in the pump cover. Refer to Figure 67.

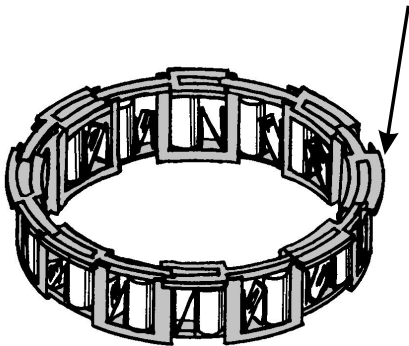
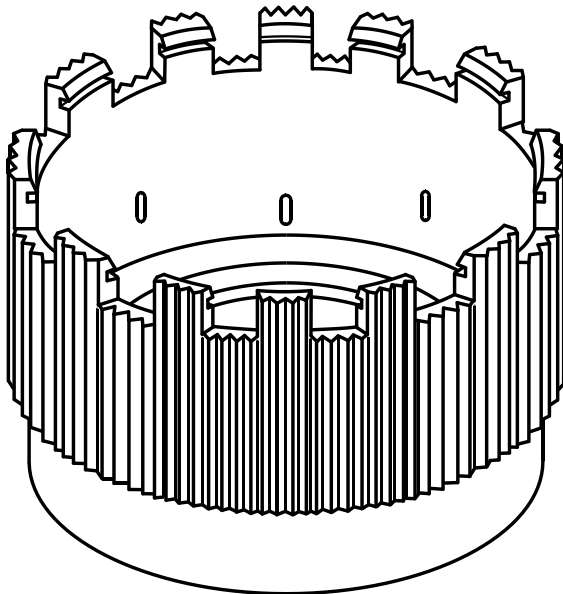
***"INCORRECTLY"
INSTALLED***

***NOTE TABS ON
TOP OUTER EDGE***

IF THE ROLLER CLUTCH IS INSTALLED IN THIS DIRECTION, THE REVERSE HUB WILL FREEWHEEL IN BOTH DIRECTIONS.

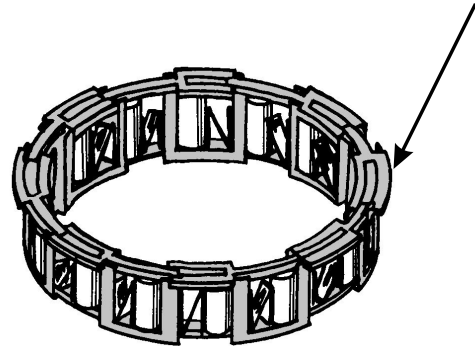
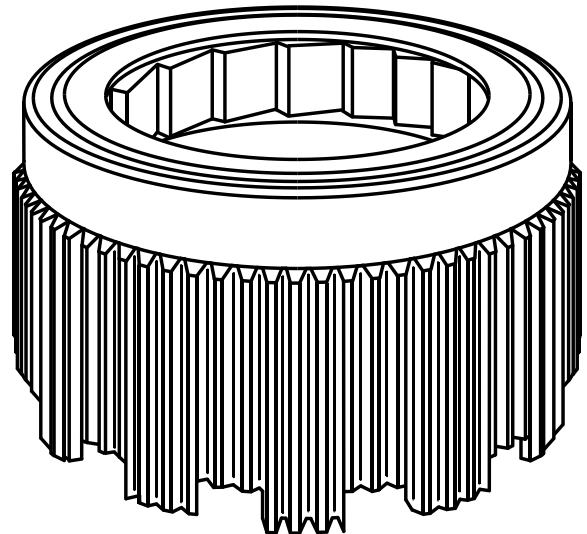
***"CORRECT"
INSTALLATION***

***NOTE TABS ON
TOP OUTER EDGE***

DISCARD BOTH SNAP RINGS. THEY ARE NOT USED WITH THE PLASTIC ROLLER CLUTCH

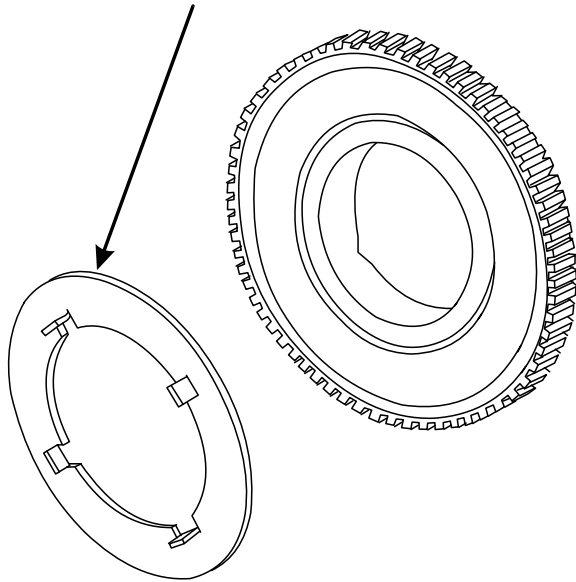
EARLY FORWARD CLUTCH RING GEAR HUB

1989-1996 RING GEAR HUB
.030" FROM WASHER SURFACE TO EDGE AS SHOWN,
AND REQUIRES THRUST WASHER SHOWN ABOVE.
(NO LONGER AVAILABLE FROM FORD)

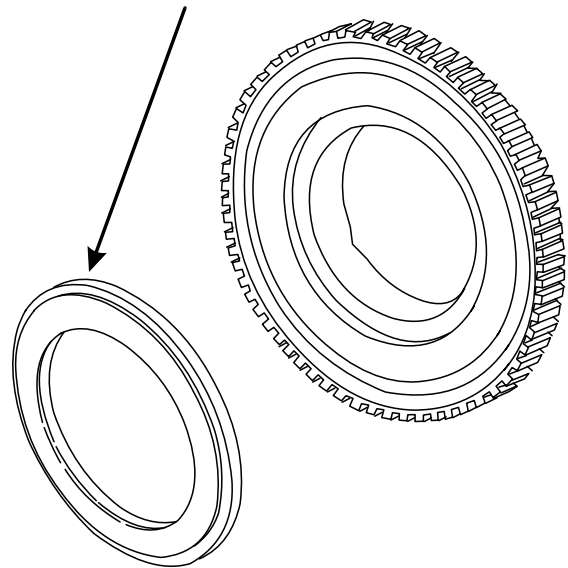
LATE FORWARD CLUTCH RING GEAR HUB

1997-UP RING GEAR HUB
.130" FROM WASHER SURFACE TO EDGE AS SHOWN,
AND REQUIRES THRUST BEARING SHOWN ABOVE.
RING GEAR HUB PART NUMBER F7TZ-7B067-AB.

When ordering the Forward Clutch Ring Gear Hub from Ford Motor Co, it will automatically supercede to the newest Service Package part number F7TZ-7B067-AB, and will come with the new design thrust bearing. When used together these parts will retro-fit back to 1989.

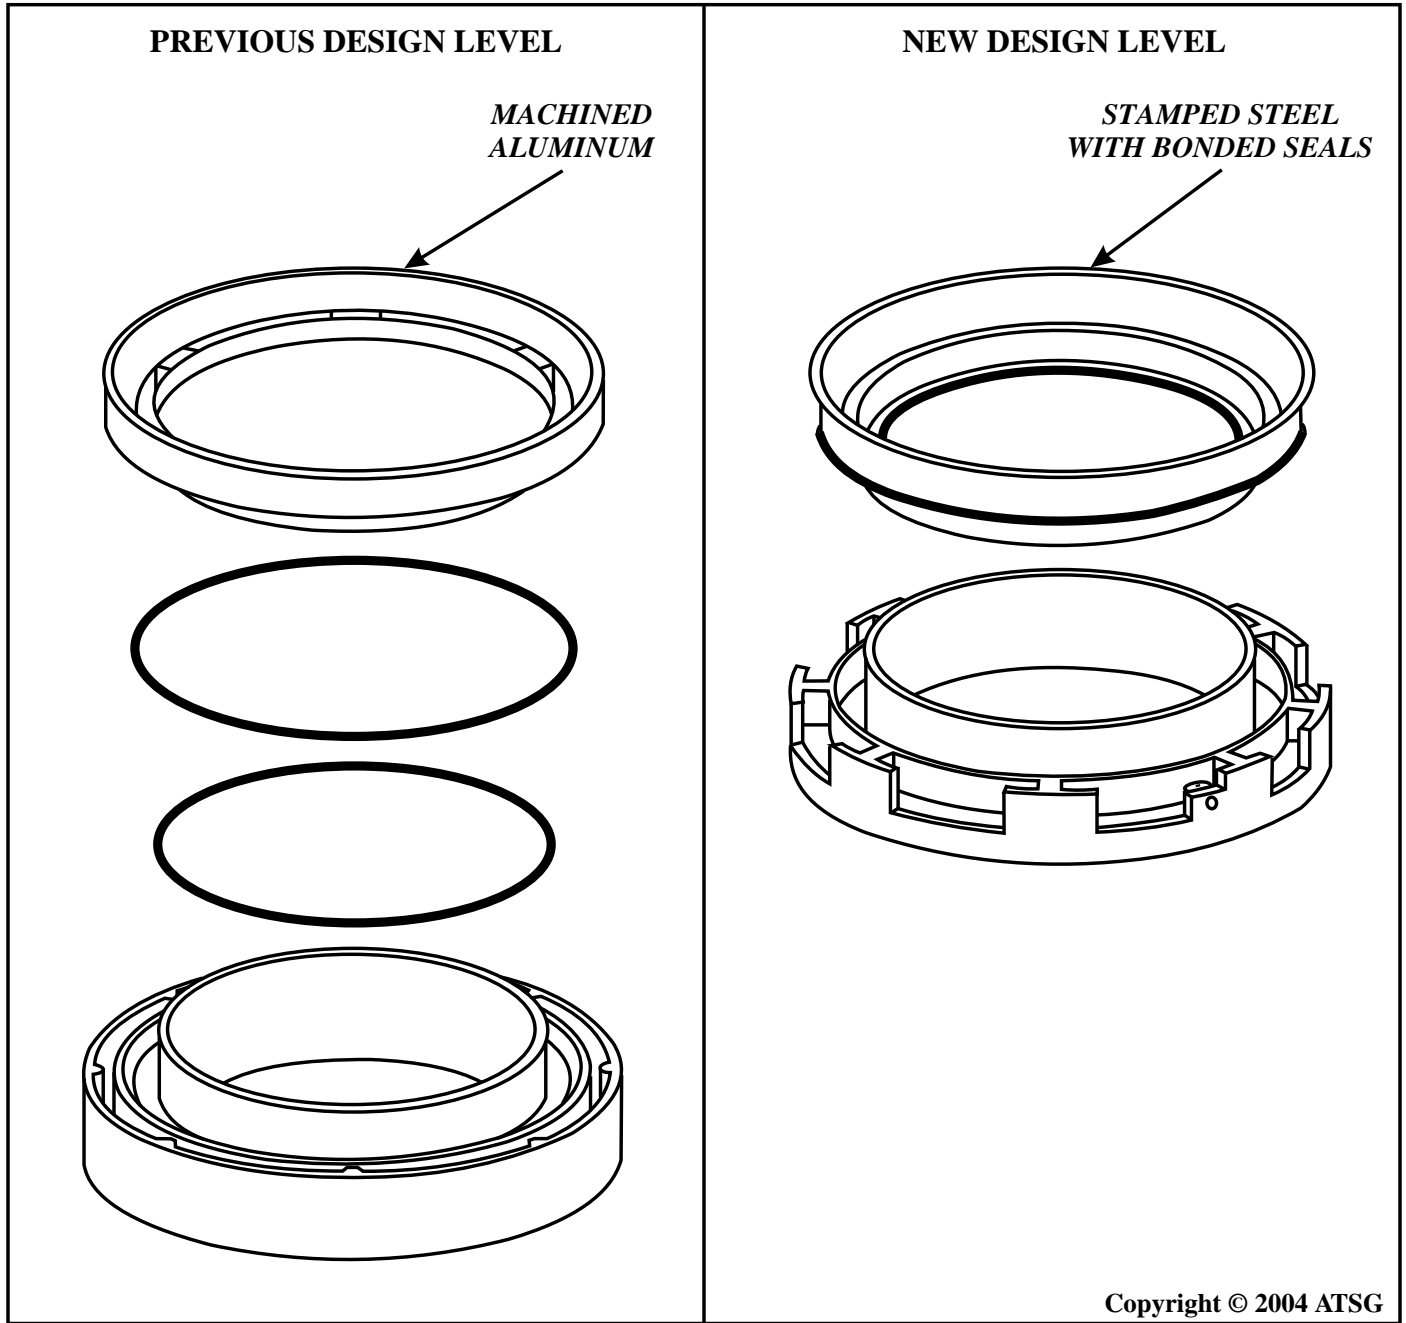
Figure 78

- (1) OVERDRIVE PISTON - Now stamped steel with moulded rubber inner and outer seals on the piston assembly, instead of the previous machined aluminum, as shown in Figure 78.
- (2) OVERDRIVE/INTERMEDIATE CLUTCH CYLINDER - Major casting changes to clutch cylinder, to accommodate the new design level bonded piston, as shown in Figure 78.

Note: Until the new design level parts are fully stocked, the current service parts must be used to replace the new design level parts, if it becomes necessary to replace either the new design bonded seal piston or new design cylinder.
