FORD E40D "UPDATE HANDBOOK"

INTRODUCTION FORD E4OD "UPDATE HANDBOOK"

**FORD E40D
VALVE BODY, SPACER PLATE, SPACER PLATE GASKETS,
CHECKBALL LOCATIONS, AND CASE CHANGES,
FOR THE 1996 MODEL YEAR**

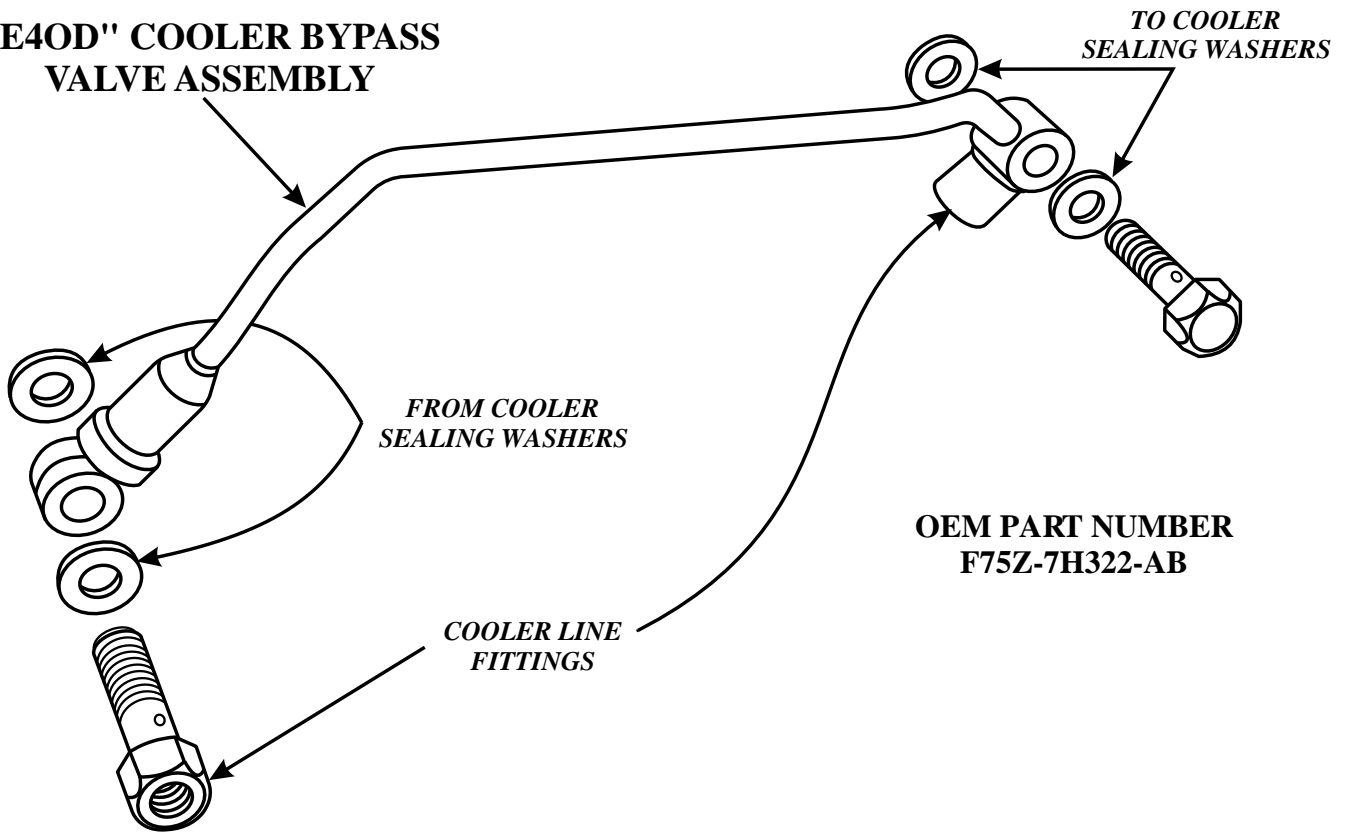
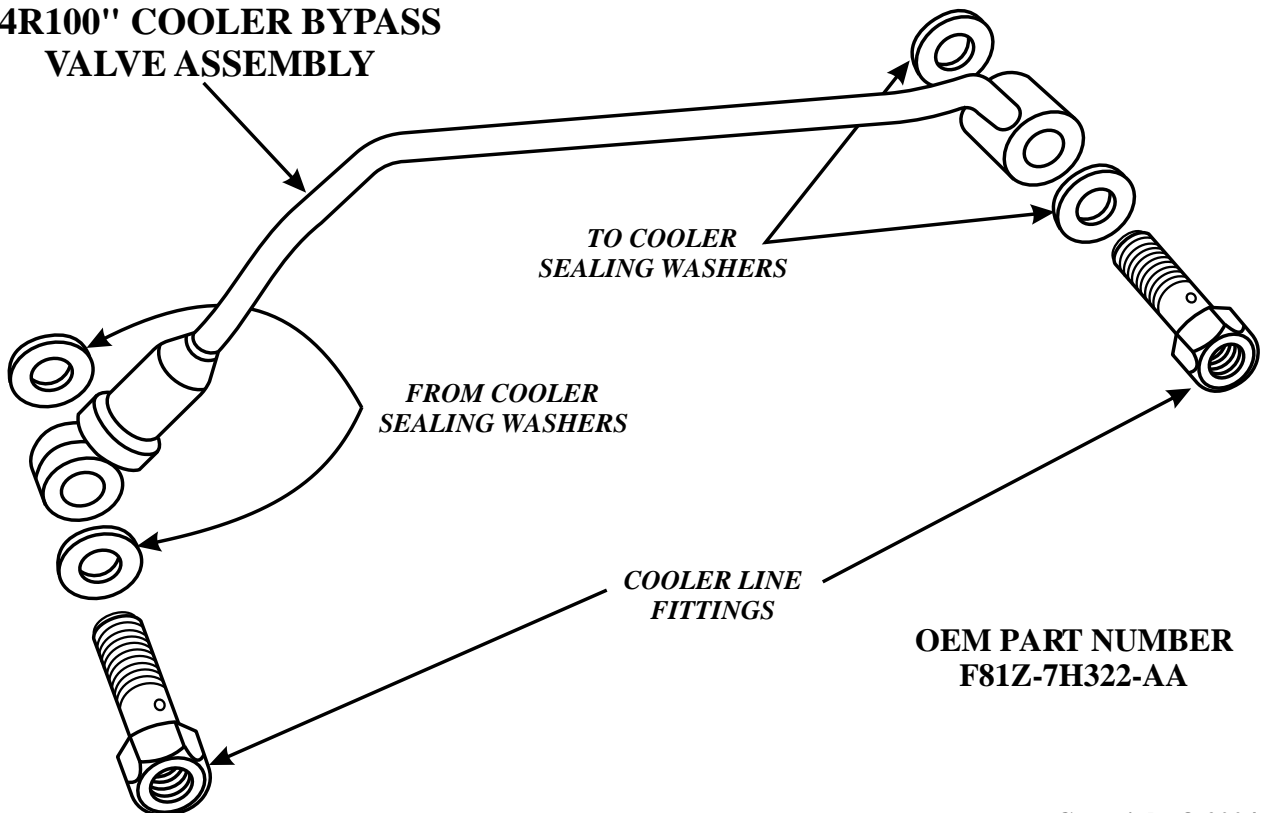
Figure 79

- (1) COOLER BYPASS VALVE ASSEMBLY - Added between the cooler line fittings in the case, to increase lube flow during cold weather operation (See Figure 79).
- (2) CASE FITTINGS - Requires special case fittings to retain the "Banjo" ends of the cooler bypass valve assembly into the transmission case (See Figure 79).
- (3) SEALING WASHERS - Requires sealing washers on both of the "Banjo" ends of the cooler bypass valve to seal properly (See Figure 79).

The new design Cooler Bypass Valve Assembly will retro-fit back to all previous models, and we would recommend the 4R100 style bypass valve assembly, as shown in Figure 79, because you do not have to bend the existing cooler line to get it hooked up.

If a removed Cooler Bypass Valve has an "O" ring installed, remove the "O" ring prior to re-installing the assembly. The "O" rings are only used to hold the sealing washers in place for shipping purposes. If the entire Cooler Bypass Valve requires replacement, be sure to remove the shipping caps and "O" rings prior to installation.

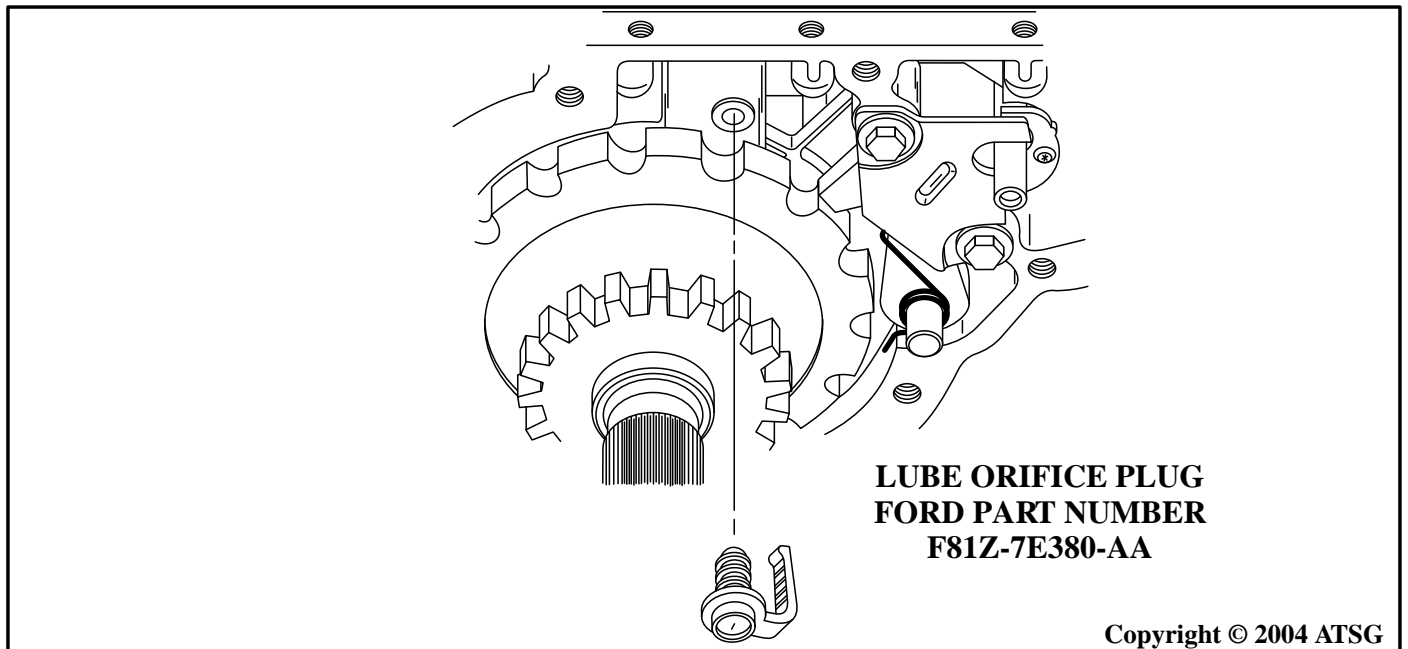
Figure 80

- (1) TRANSMISSION CASE - Added passage at the rear of transmission case to accept the added plastic lube orifice plug, as shown in Figure 80.
- (2) EXTENSION HOUSING - Added cast-in shoulder/boss that retains the added lube orifice plug in the transmission case, as shown in Figure 81.

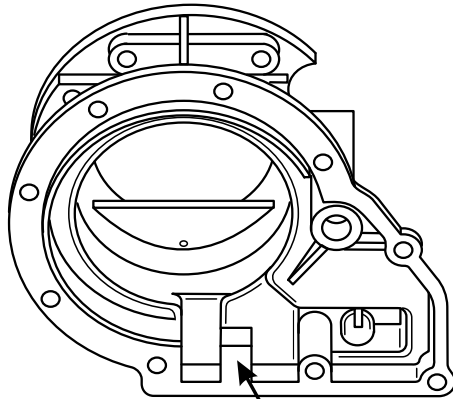
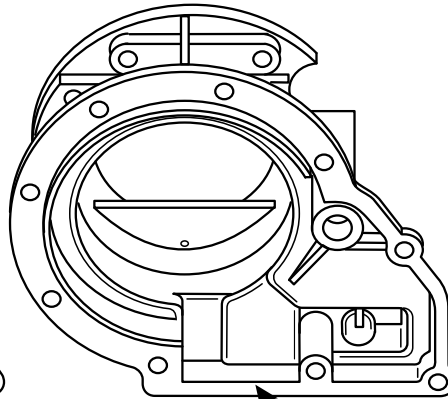
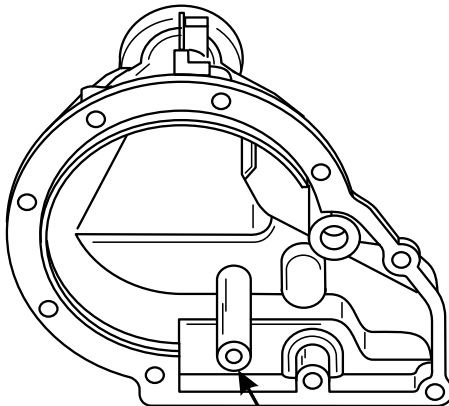
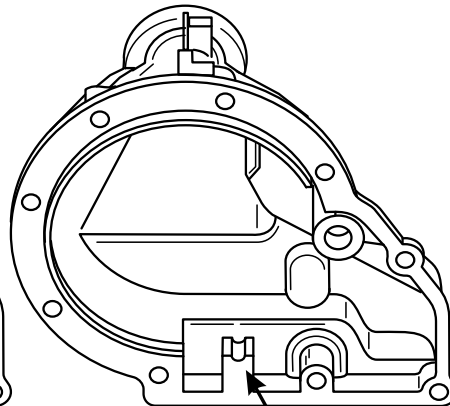
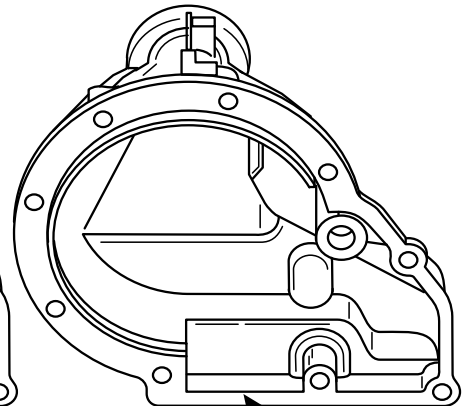
Figure 81

- (1) The new design extension housing *with* the added cast-in shoulder or boss will service *any* E4OD transmission case, past or present (See Figure 81).
- (2) The previous design extension housing *without* the cast-in shoulder or boss can only be used on transmission cases built prior to 7/24/97 not having the lube orifice plug (See Figure 81).

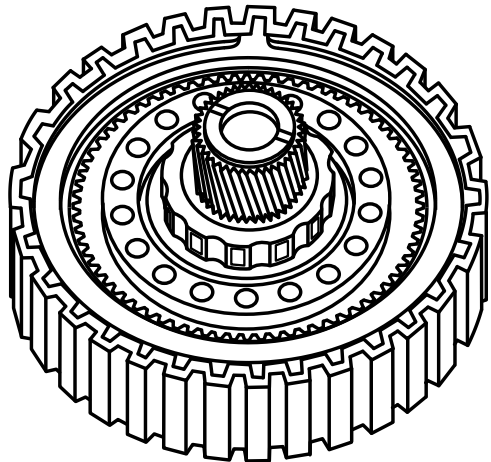
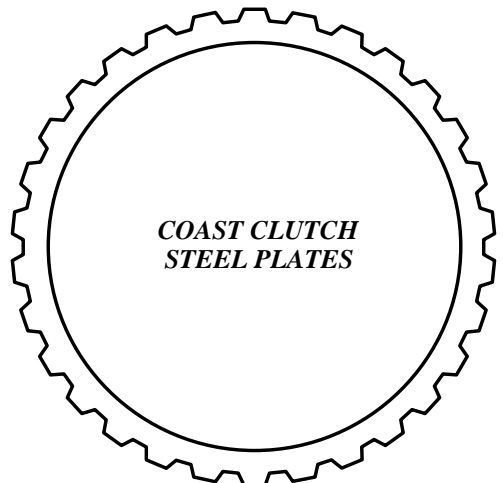
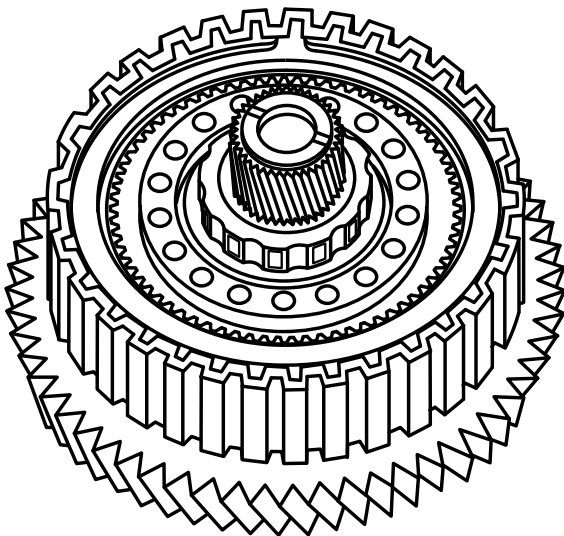
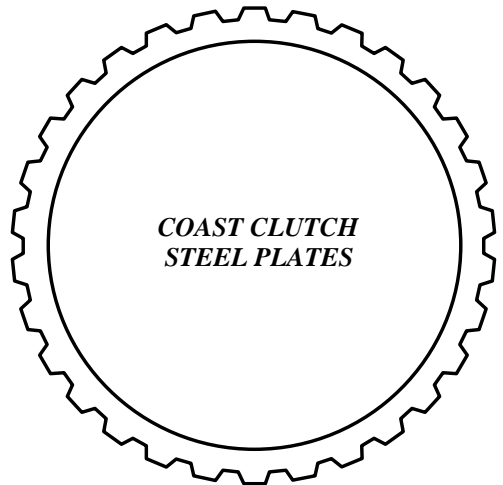
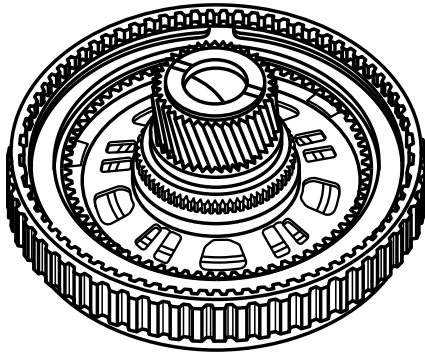
Figure 87

- (5) COAST CLUTCH HOUSING - There is now a "stamped Steel" coast clutch housing that may or may not have a PTO gear pressed onto the housing, that is used in addition to the previous cast iron coast clutch housing, depending on the model and engine size, and is illustrated in Figure 87. This also changes the coast clutch steel plates and the fourth clutch friction plates, as shown in Figures 87 and 88.

**"CAST IRON" COAST CLUTCH DRUM USED
WITH 5.4L AND 6.8L "WITHOUT" PTO OPTION**

**"STAMPED STEEL" COAST CLUTCH DRUM USED
WITH 5.4L AND 6.8L "WITHOUT" PTO OPTION**

**"STAMPED STEEL" COAST CLUTCH DRUM USED
WITH 6.8L AND 7.3L "WITH" PTO OPTION**

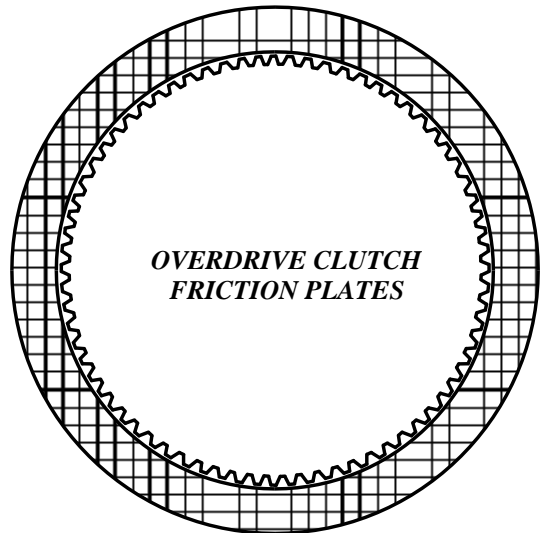
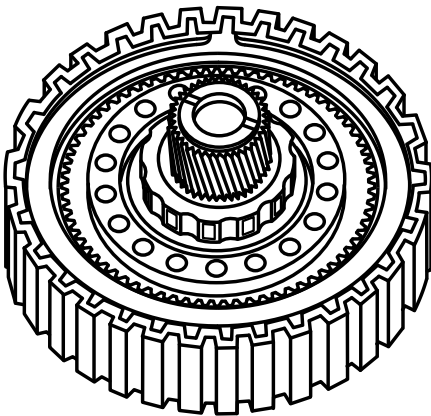
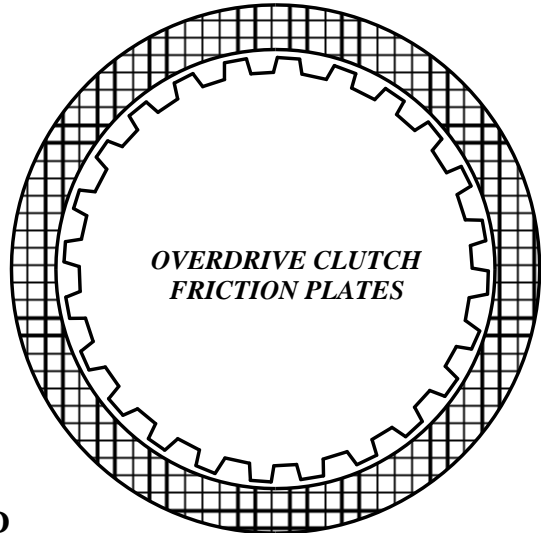
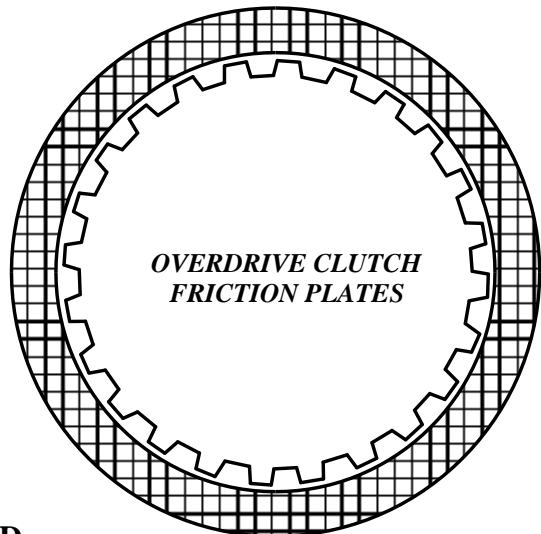
Figure 88

"CAST IRON" COAST CLUTCH DRUM USED WITH 5.4L AND 6.8L "WITHOUT" PTO OPTION

"STAMPED STEEL" COAST CLUTCH DRUM USED WITH 5.4L AND 6.8L "WITHOUT" PTO OPTION

"STAMPED STEEL" COAST CLUTCH DRUM USED WITH 6.8L AND 7.3L "WITH" PTO OPTION

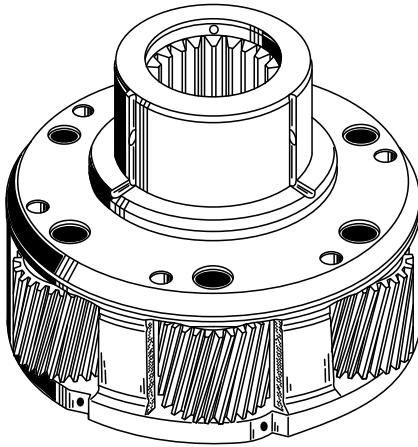
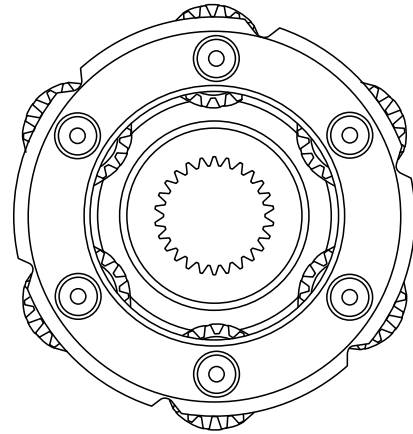
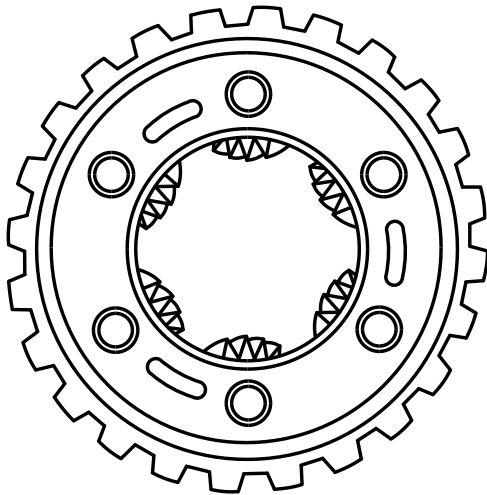
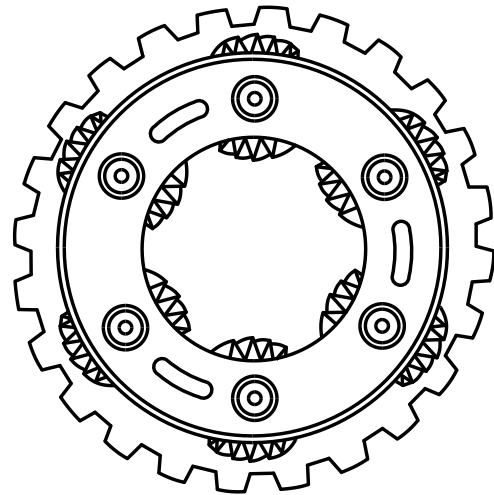
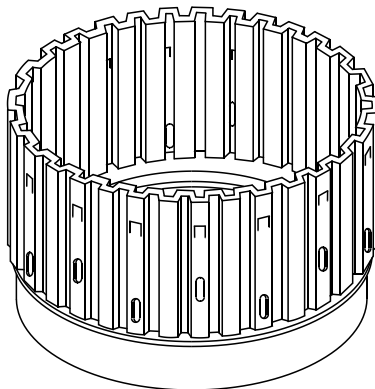
Figure 89

CHANGE: Beginning at the start of production for all 1998 model E4OD transmissions, *some models* will be equipped with a new design 6 pinion forward planetary carrier, and a new design 6 pinion reverse planetary carrier, as shown in Figure 89.

- (1) FORWARD PLANETARY CARRIER - Now has 6 pinions instead of the previous 4 pinions for increased torque carrying capacity and increased durability (See Figure 89).
- (2) REVERSE PLANETARY CARRIER - Now has 6 pinions instead of the previous 4 pinions for increased torque carrying capacity and increased durability (See Figure 89).

**NEW DESIGN 6 PINION FORWARD PLANETARY CARRIER
PART NUMBER F81Z-7A398-CA**

**NEW DESIGN 6 PINION REVERSE PLANETARY CARRIER
PART NUMBER F81Z-7D006-AA**

The new design forward planetary carrier *will back service all models* of the E4OD, but it *does require* the latest design forward ring gear hub and bearing assembly, as there are no holes for the previous design thrust washer (See Figure 89).

The new design reverse planetary carrier *will back service all models* of the E4OD, but it *does require* the latest design reverse clutch hub and three tang thrust washer for both sides, as shown in Figure 89.

**REQUIRES 1997-UP DESIGN LEVEL
REVERSE CLUTCH HUB ASSEMBLY**

**REQUIRES 3 TANG THRUST WASHERS
ON BOTH SIDES OF REAR CARRIER
PART NUMBER F0TZ-7A166-D**

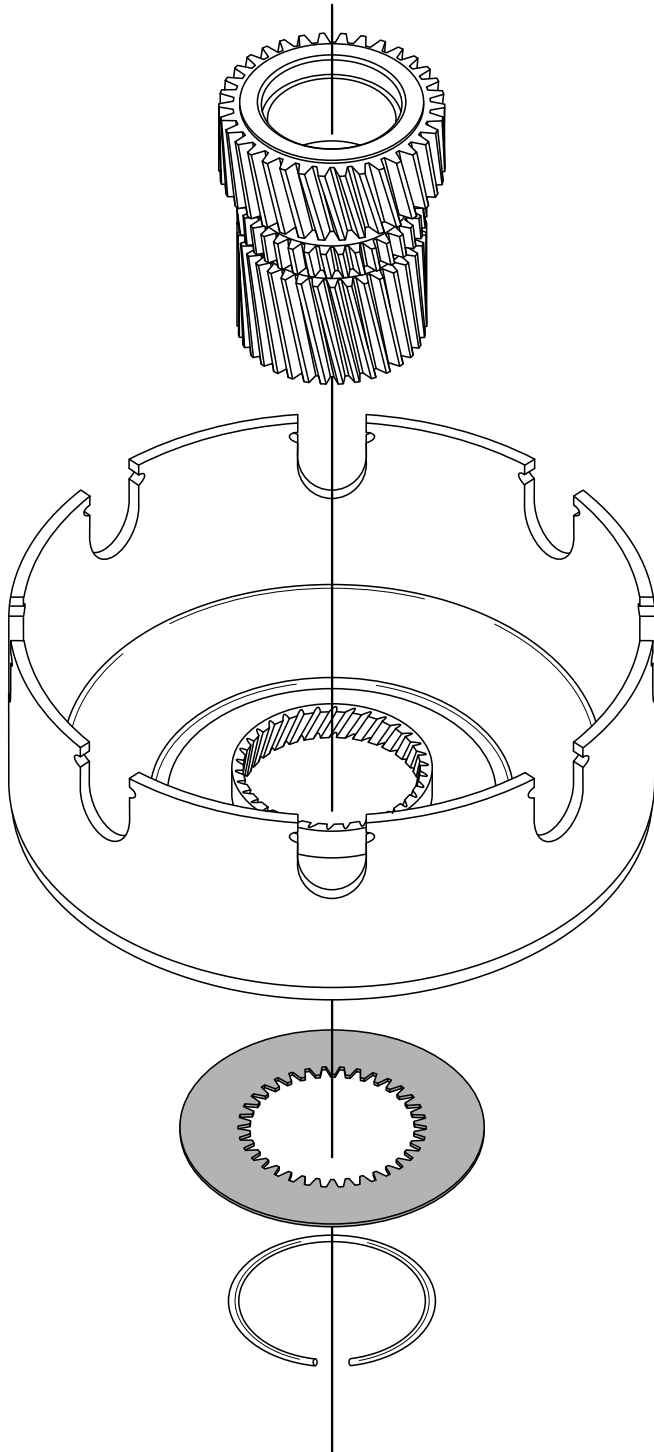
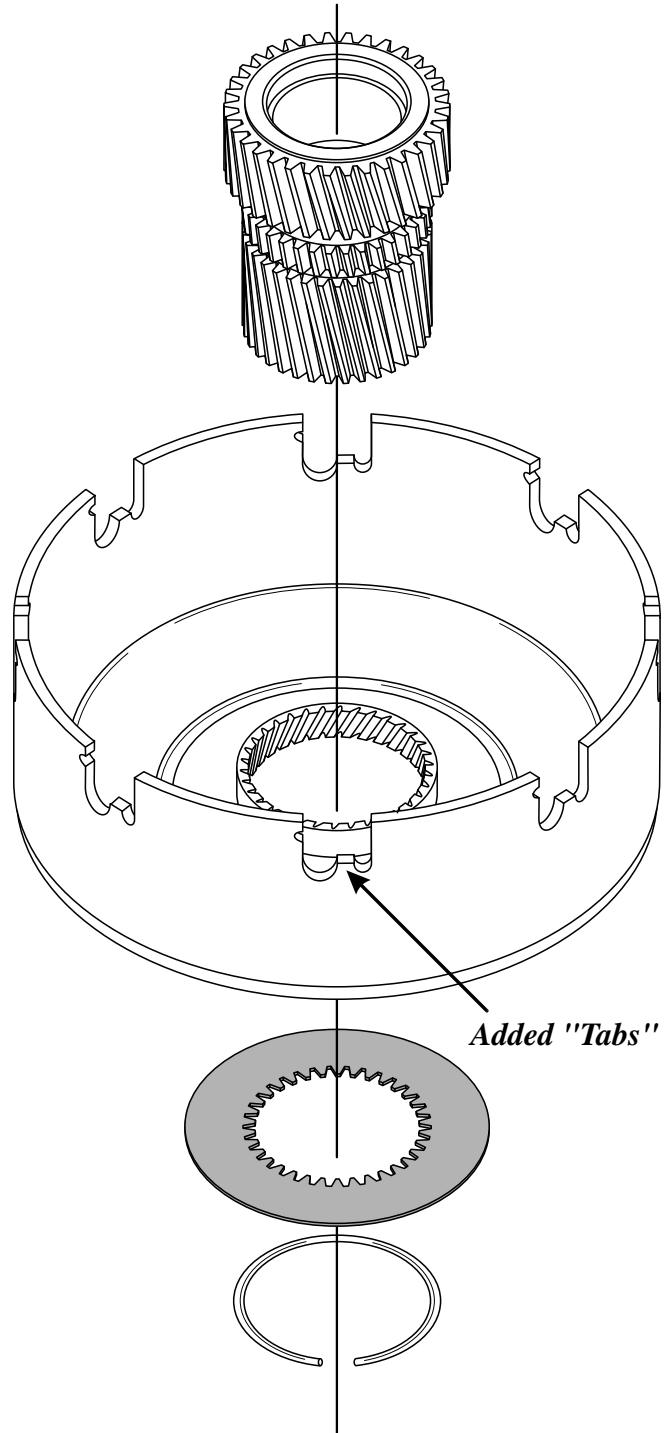
Figure 90

CHANGE: There is now a new design Sun Shell with "Tabs" added to the center of the sun shell slots, as shown in Figure 90, implemented by Ford Motor Co. as a running change, during the 2000 model year. This change eliminated the need for the number 8 thrust washer between the forward and direct drums.

PREVIOUS DESIGN SUN SHELL
"No Longer Available From Ford"

NEW DESIGN SUN SHELL
*Hardened = YC3Z-7D064-BA
Regular = YC3Z-7D064-AA*

*May Be Used With "ONLY"
The Previous Design Direct Drum
And Requires The No. 8 Washer
(See Figure 91)*

*May Be Used With
Both Design Direct Drums
With Or Without Washer
(See Figure 91)*

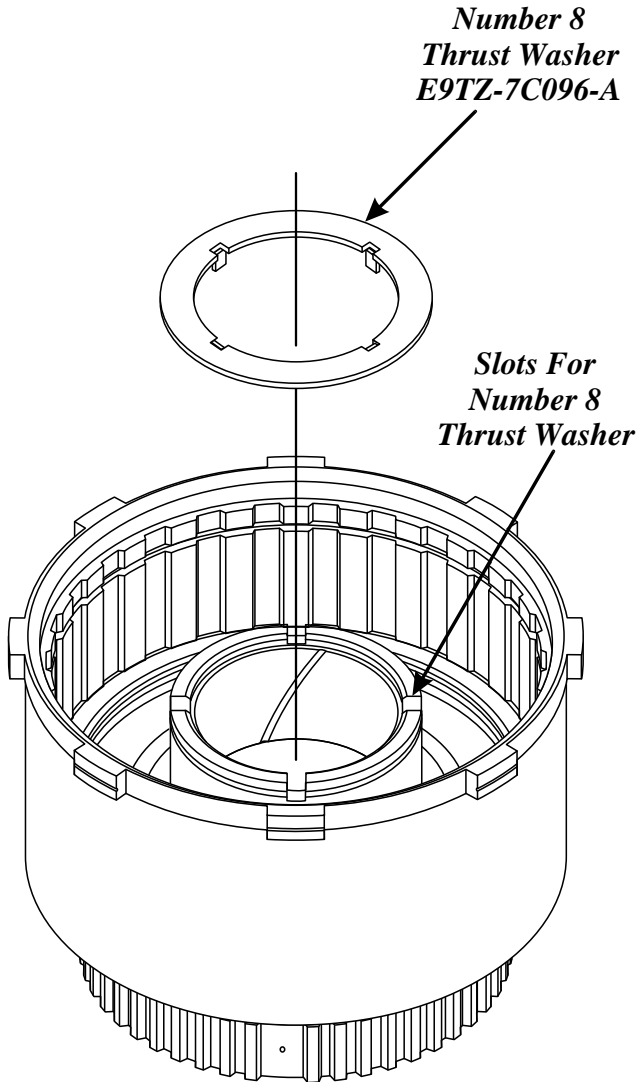
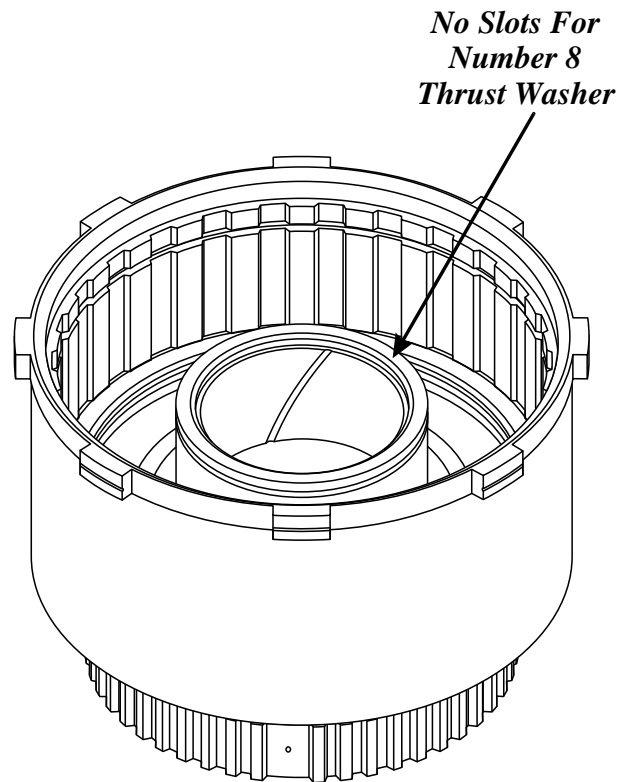
Figure 91

**PREVIOUS DESIGN DIRECT CLUTCH
DRUM "WITH" SLOTS FOR THE
NUMBER 8 THRUST WASHER
PART NO. F81Z-7D044-BA**

**NEW DESIGN DIRECT CLUTCH
DRUM "WITHOUT" SLOTS FOR THE
NUMBER 8 THRUST WASHER
PART NO. YC3Z-7D044-BA**

*May Be Used With
Both Design Sun Shells
(See Figure 90)*

*May Be Used With "ONLY"
The New Design Sun Shell
(See Figure 90)*

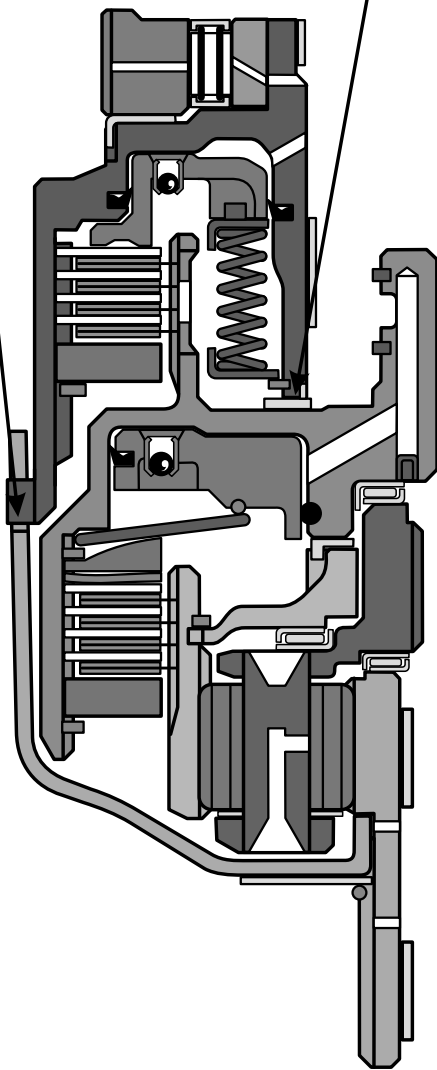
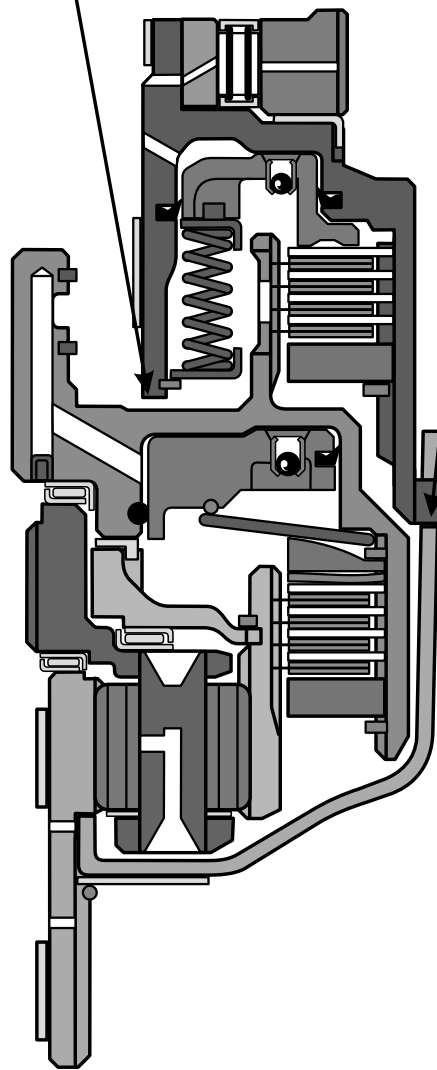
Figure 92

*When Direct Clutch Housing
Is Not Supported Here,*

*The Number 8 Thrust
Washer Is Required*

**NEW DESIGN DIRECT CLUTCH
DRUM "WITHOUT" SLOTS FOR THE
NUMBER 8 THRUST WASHER
AND NEW SUNSHELL**

*When Direct Clutch Housing
Is Supported By The "Added"
Raised Tabs Here,*

*The Number 8 Thrust
Washer Is Not Required*

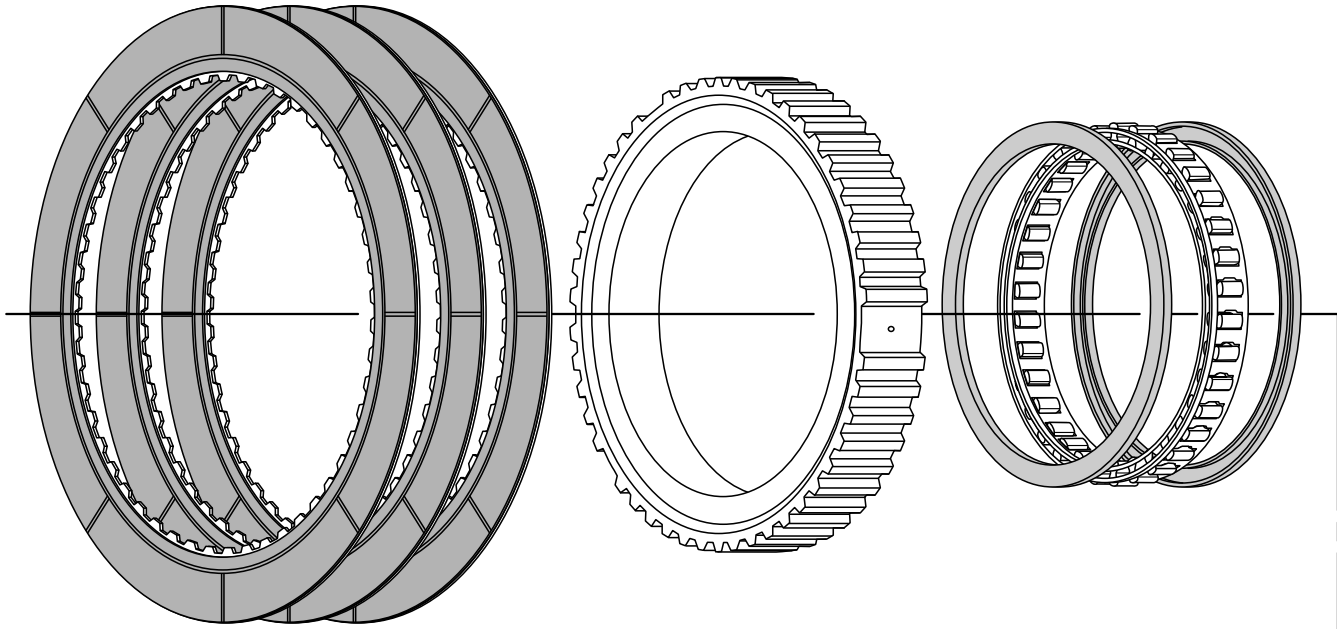
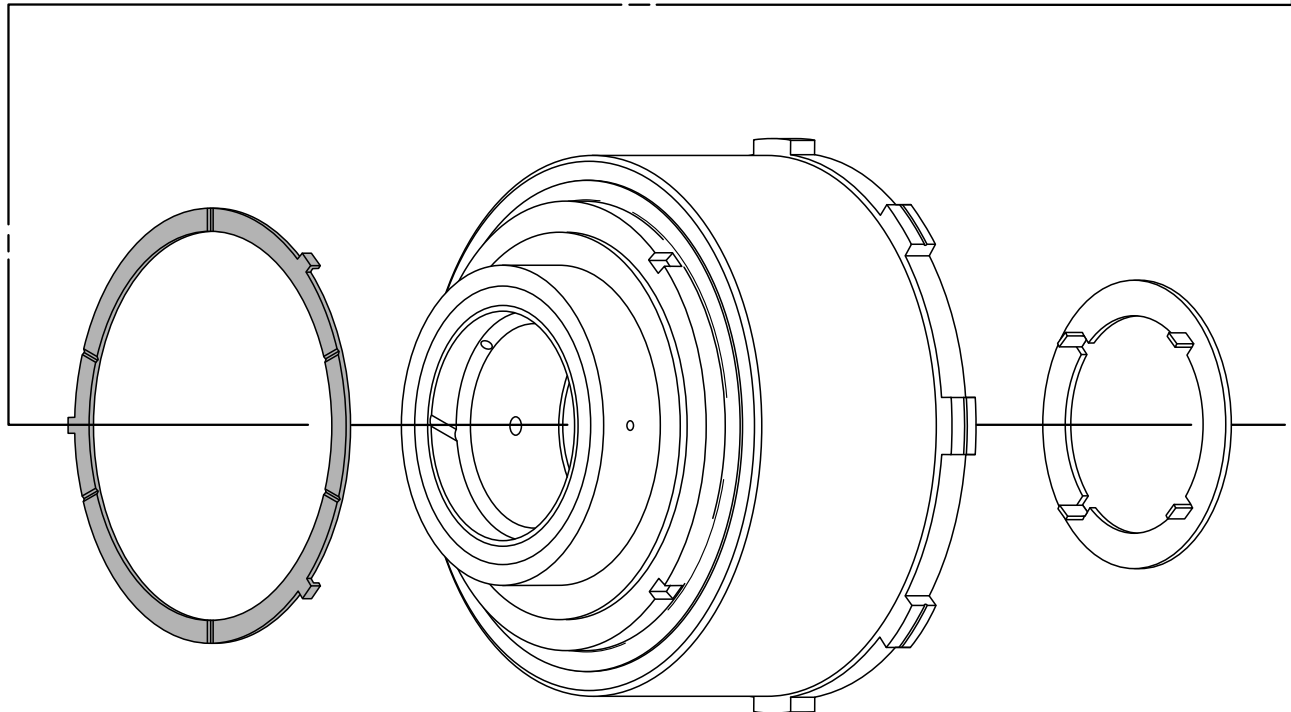
COMPLAINT: Some Ford Motor Company vehicles equipped with the 4R100 transmission may exhibit premature failure of the newly introduced Intermediate "Diode" Freewheel device that was installed in model year 2001 and illustrated in Figure 93.

CAUSE: The cause may be, more than expected load factors.

CORRECTION: The Intermediate "Diode" is *no longer serviced* by Ford Motor Company. The part number now supercedes to all of the previous design level parts, which include the direct clutch housing, intermediate sprag assembly, outer race to direct drum thrust washer, and the intermediate friction plates. All of the previous design level parts are illustrated in Figure 94, with the OEM part numbers. The intermediate frictions must be replaced because the tooth count on the outer race between the diode and the sprag are different.

Special Note: ATSG recommends replacing the Intermediate "Diode" during service, even if it has not yet failed, to protect yourself from possible future failures.

PARTS NEEDED TO REPLACE INTERMEDIATE DIODE

Intermediate Friction Plates
Part Number 1C3Z-7B164-BA
(Or Raybestos Plates OK)
(3 Required)

Intermediate Sprag Assembly
Part Number E9TZ-7A089-B

Outer Race To Drum Thrust Washer
Part Number E9TZ-7G401-A

Direct Clutch Housing
Part No. YC3Z-7D044-BA (No Washer)
Part No. F81Z-7D044-BA (With Washer)

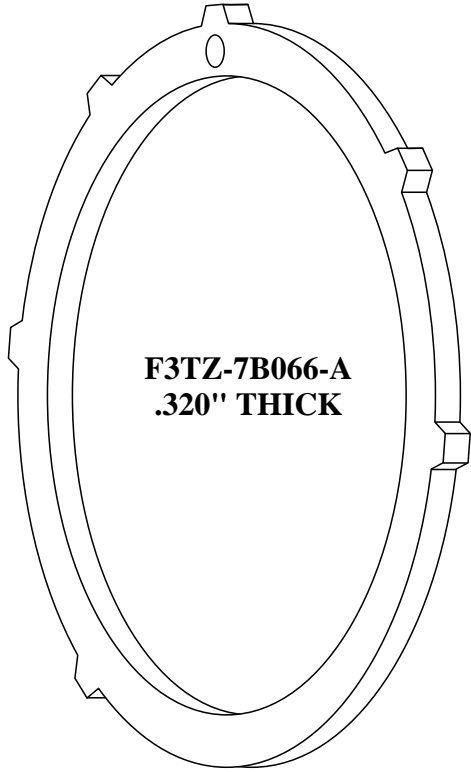
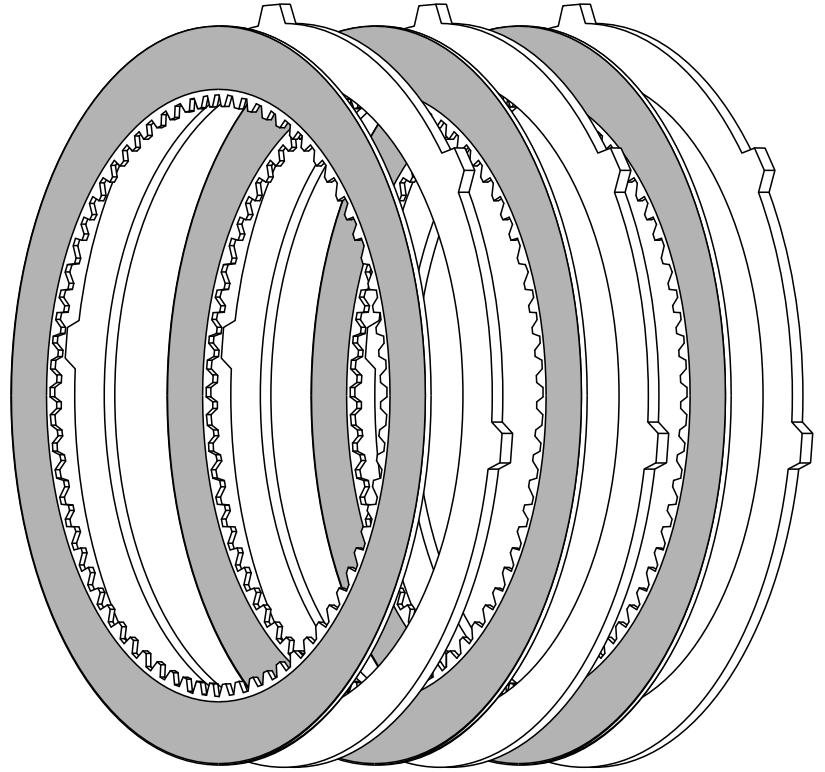
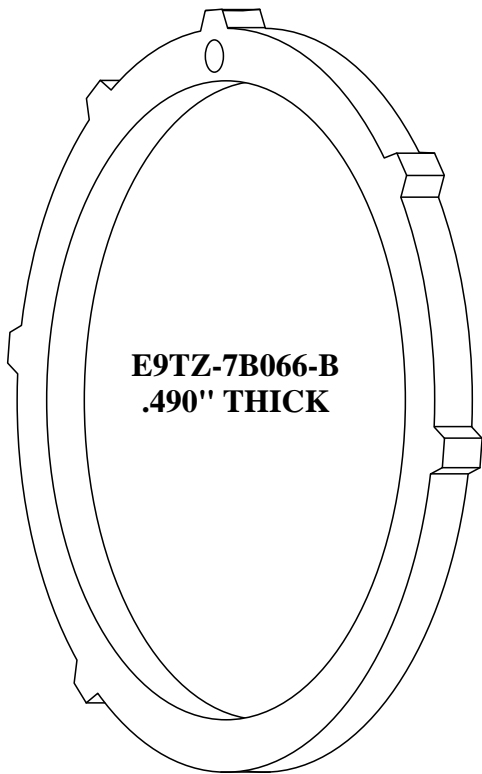
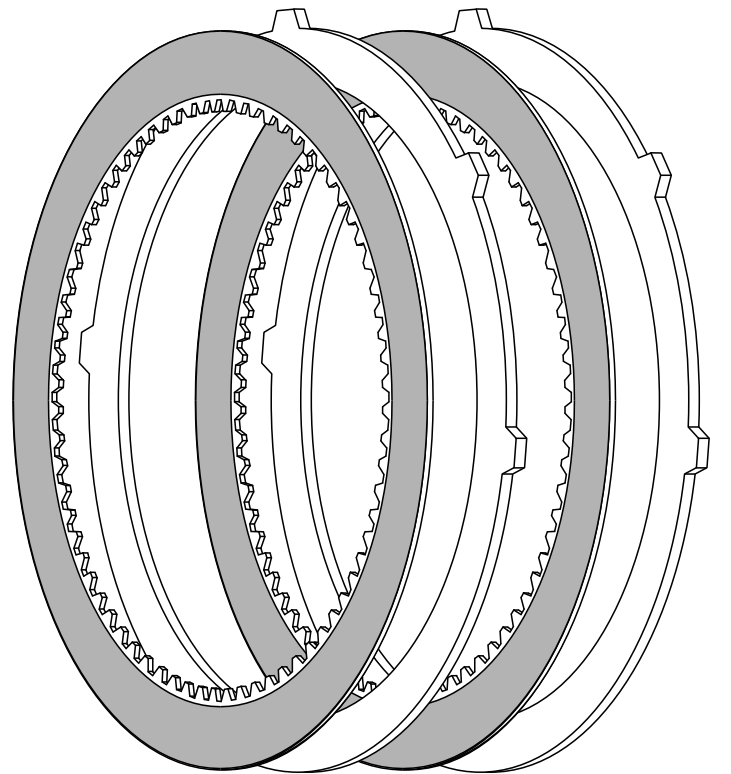
COMPLAINT: Some vehicles equipped with the E4OD transmission may exhibit premature failure of the overdrive clutches, especially heavier loaded vehicles.

CAUSE: The cause may be, not enough clutch capacity for the overdrive clutch.

E4OD 3 PLATE OVERDRIVE CLUTCH STACK-UP

E4OD 2 PLATE OVERDRIVE CLUTCH STACK-UP

CORRECTION: Install 3 clutches in the overdrive clutch pack by purchasing a thinner, .320" thick backing plate, to replace the previous .490" thick backing plate. The 3 clutch backing plate is available under OEM part number F3TZ-7B066-A. Refer to Figure 95 for both the 2 clutch and 3 clutch stack-ups.

- Overdrive Clutch Backing Plate (3 Clutch) F3TZ-7B066-A
- Overdrive Clutch Backing Plate (2 Clutch) E9TZ-7B066-B
