## AIRCONDITIONER AMPLIFIER ASSY REPLACEMENT

550QN-01

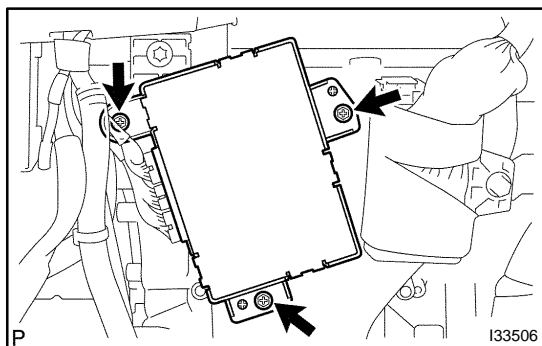
8. REMOVE AIRCONDITIONER AMPLIFIER ASSY
  - (a) Disconnect the connectors.
  - (b) Remove the 3 screws and air conditioner amplifier assy.
