REFRIGERANT

ON-VEHICLE INSPECTION

550QC-01

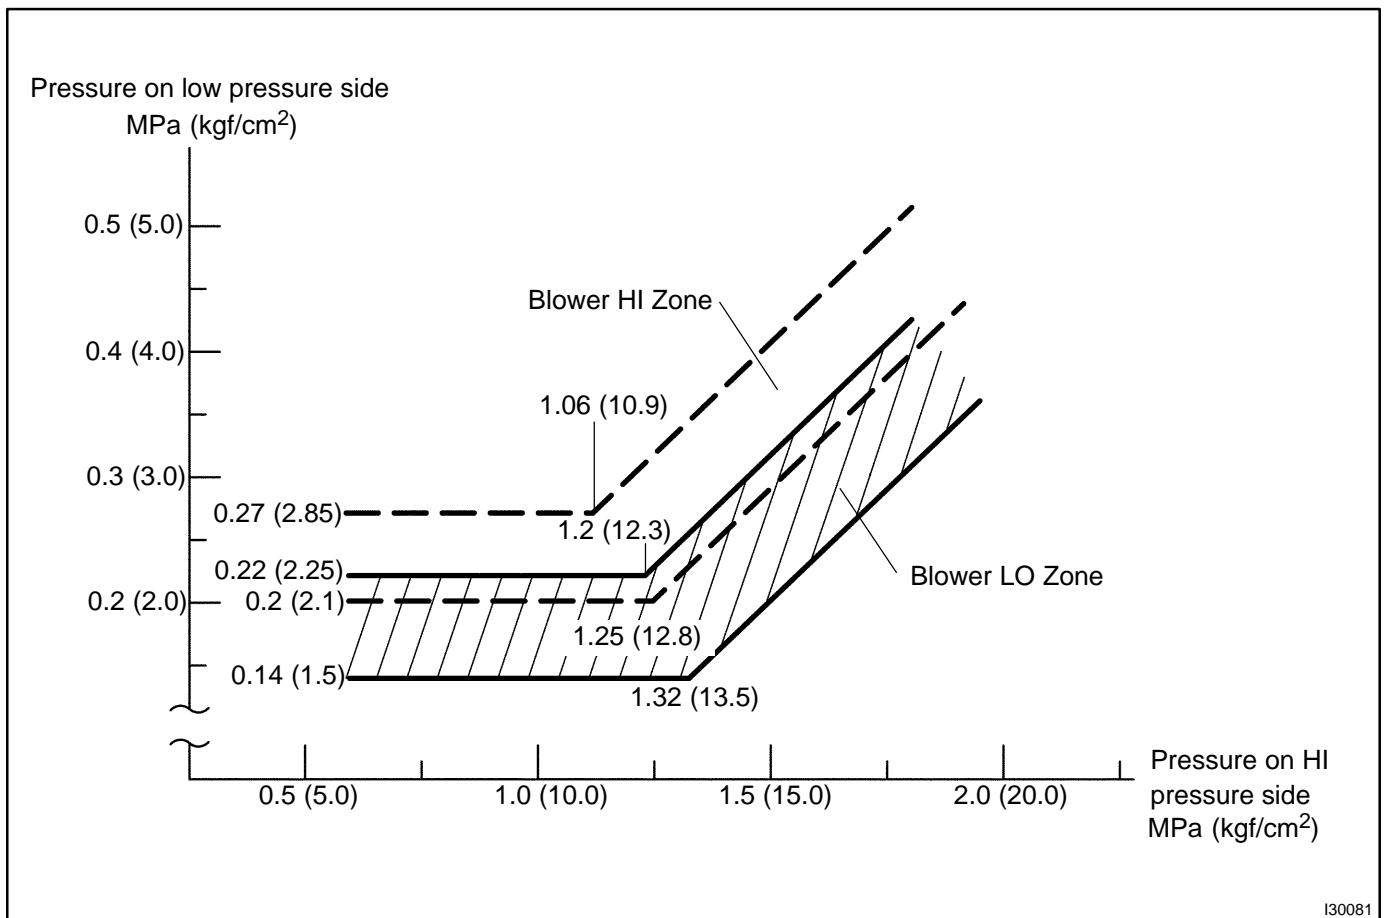
Gauge readings (Reference)
